REQUEST FOR INFORMATION

Project Name: York Region Admin., Package D Renovation

REFERENCE: [Ground, 2nd & 3rd Floor Chilled Water Main](#)

Ground, 2nd & 3rd floor chilled water main

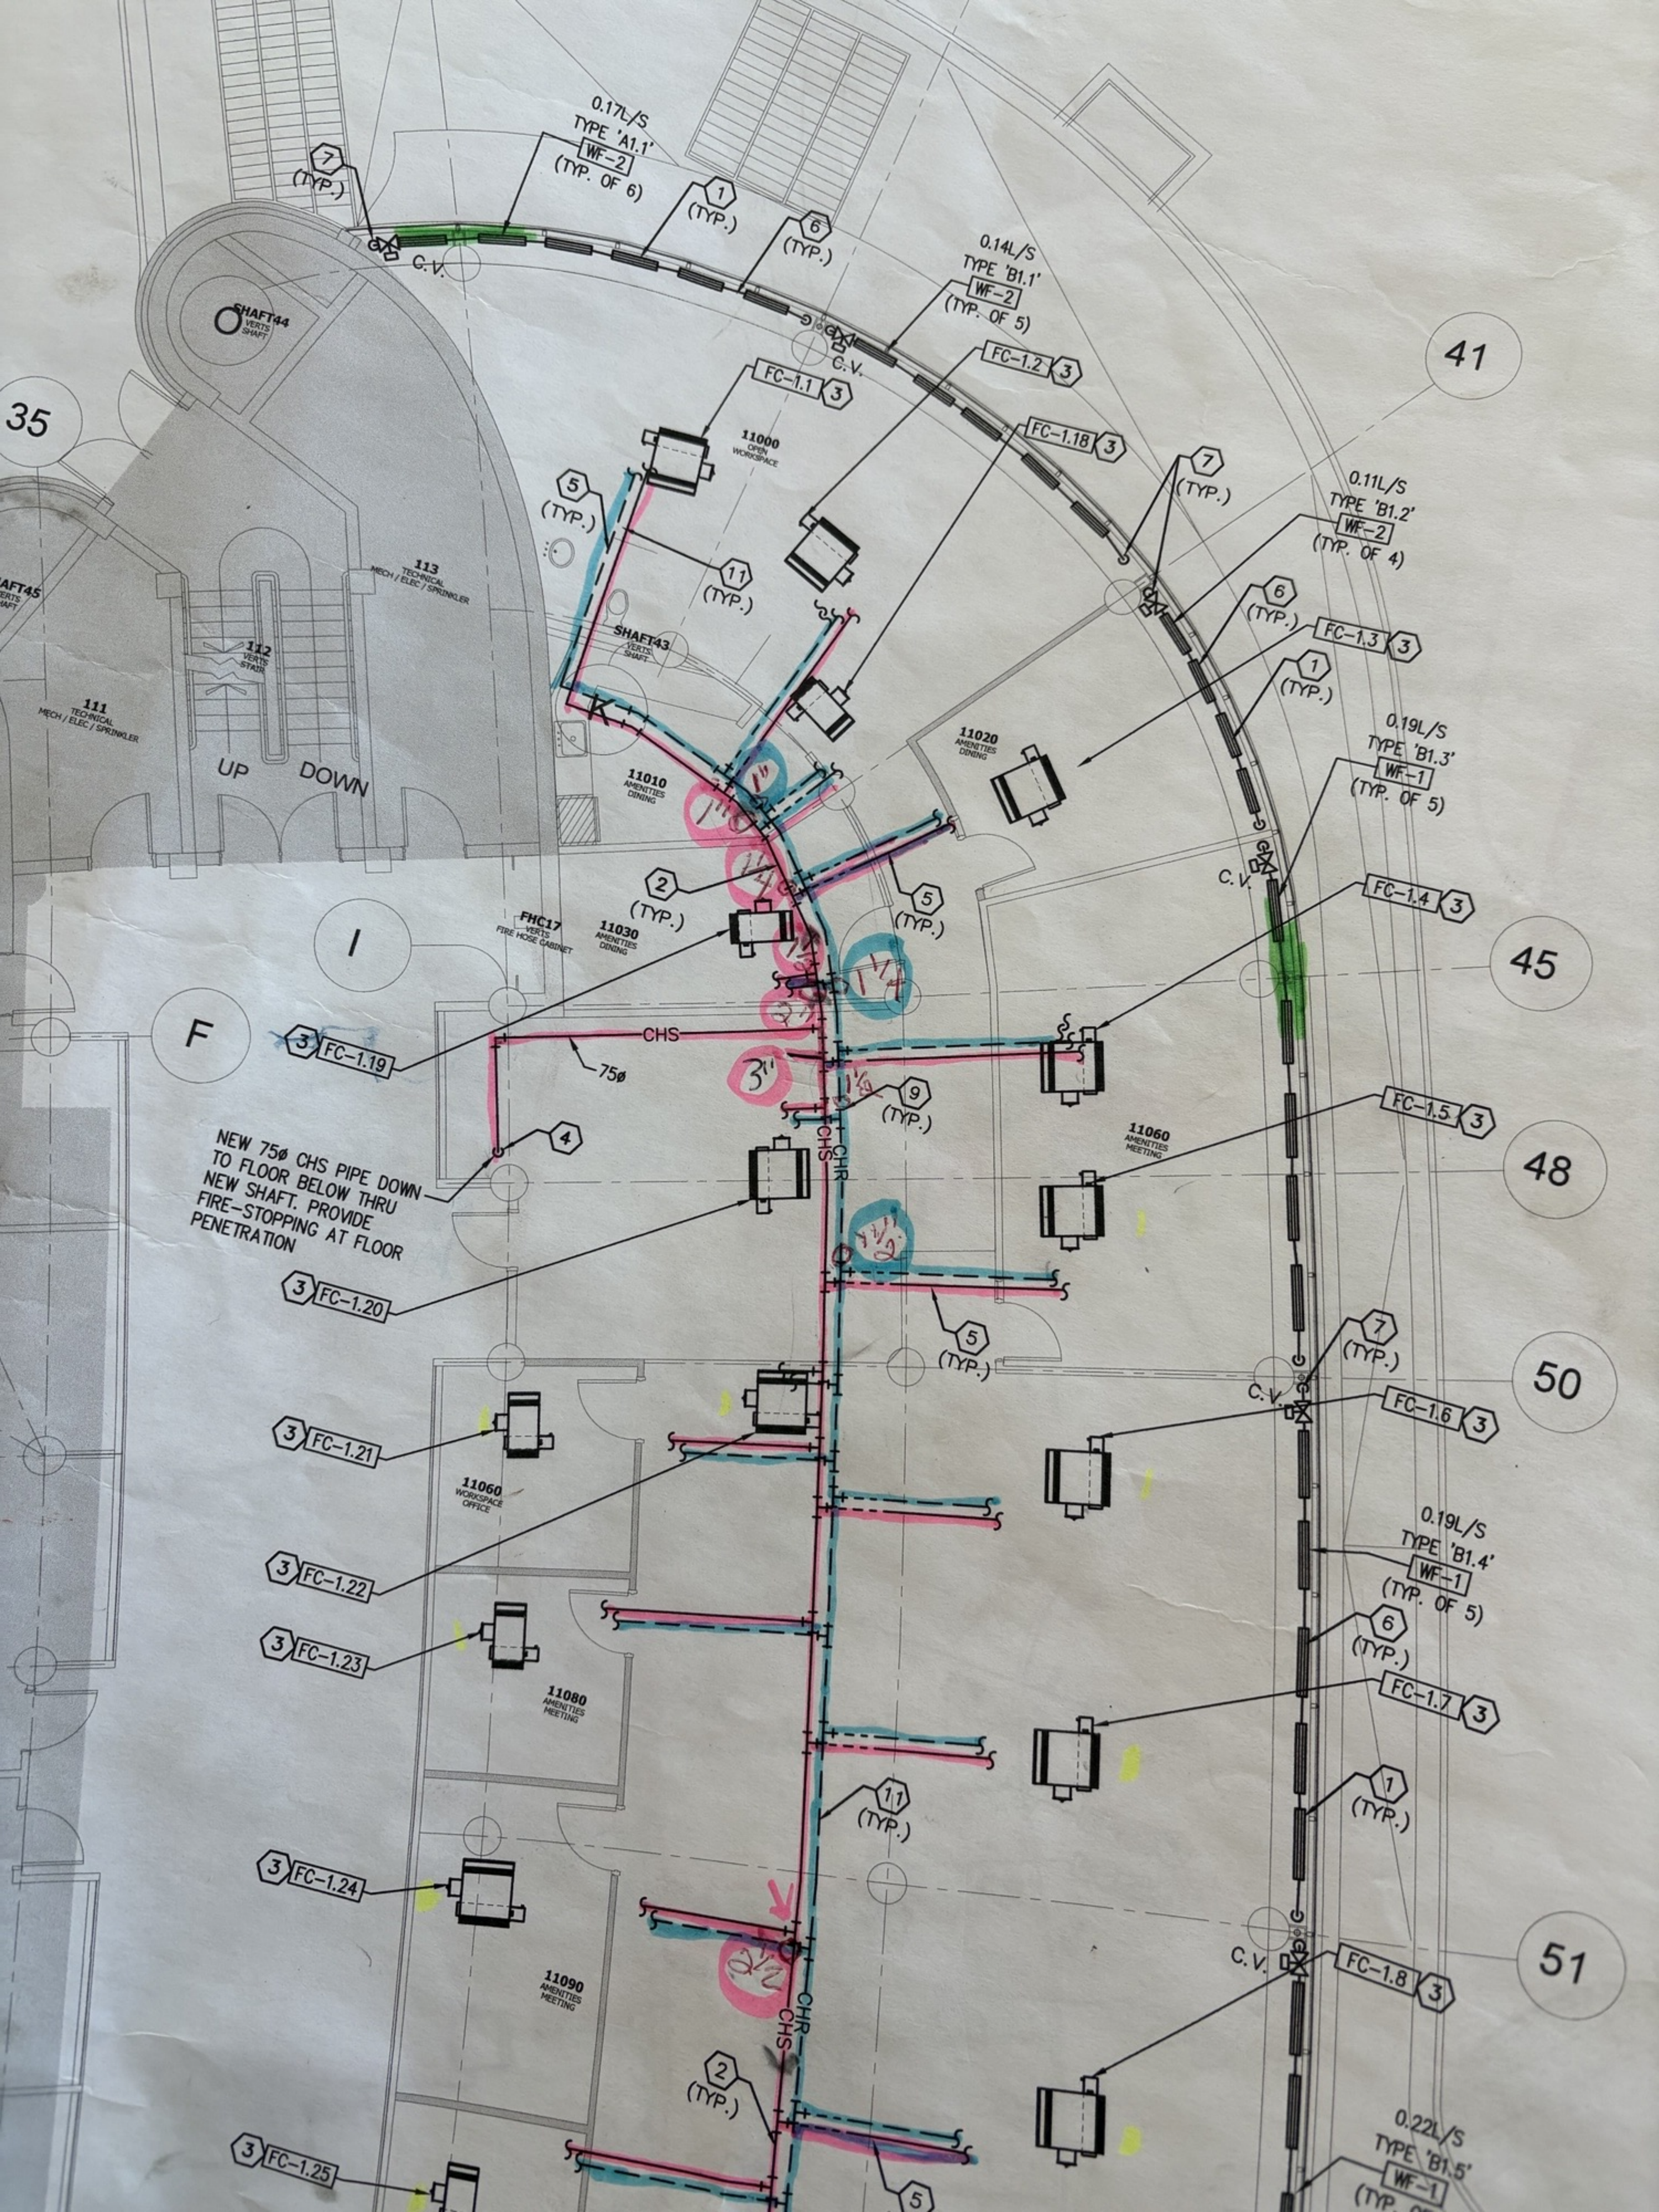
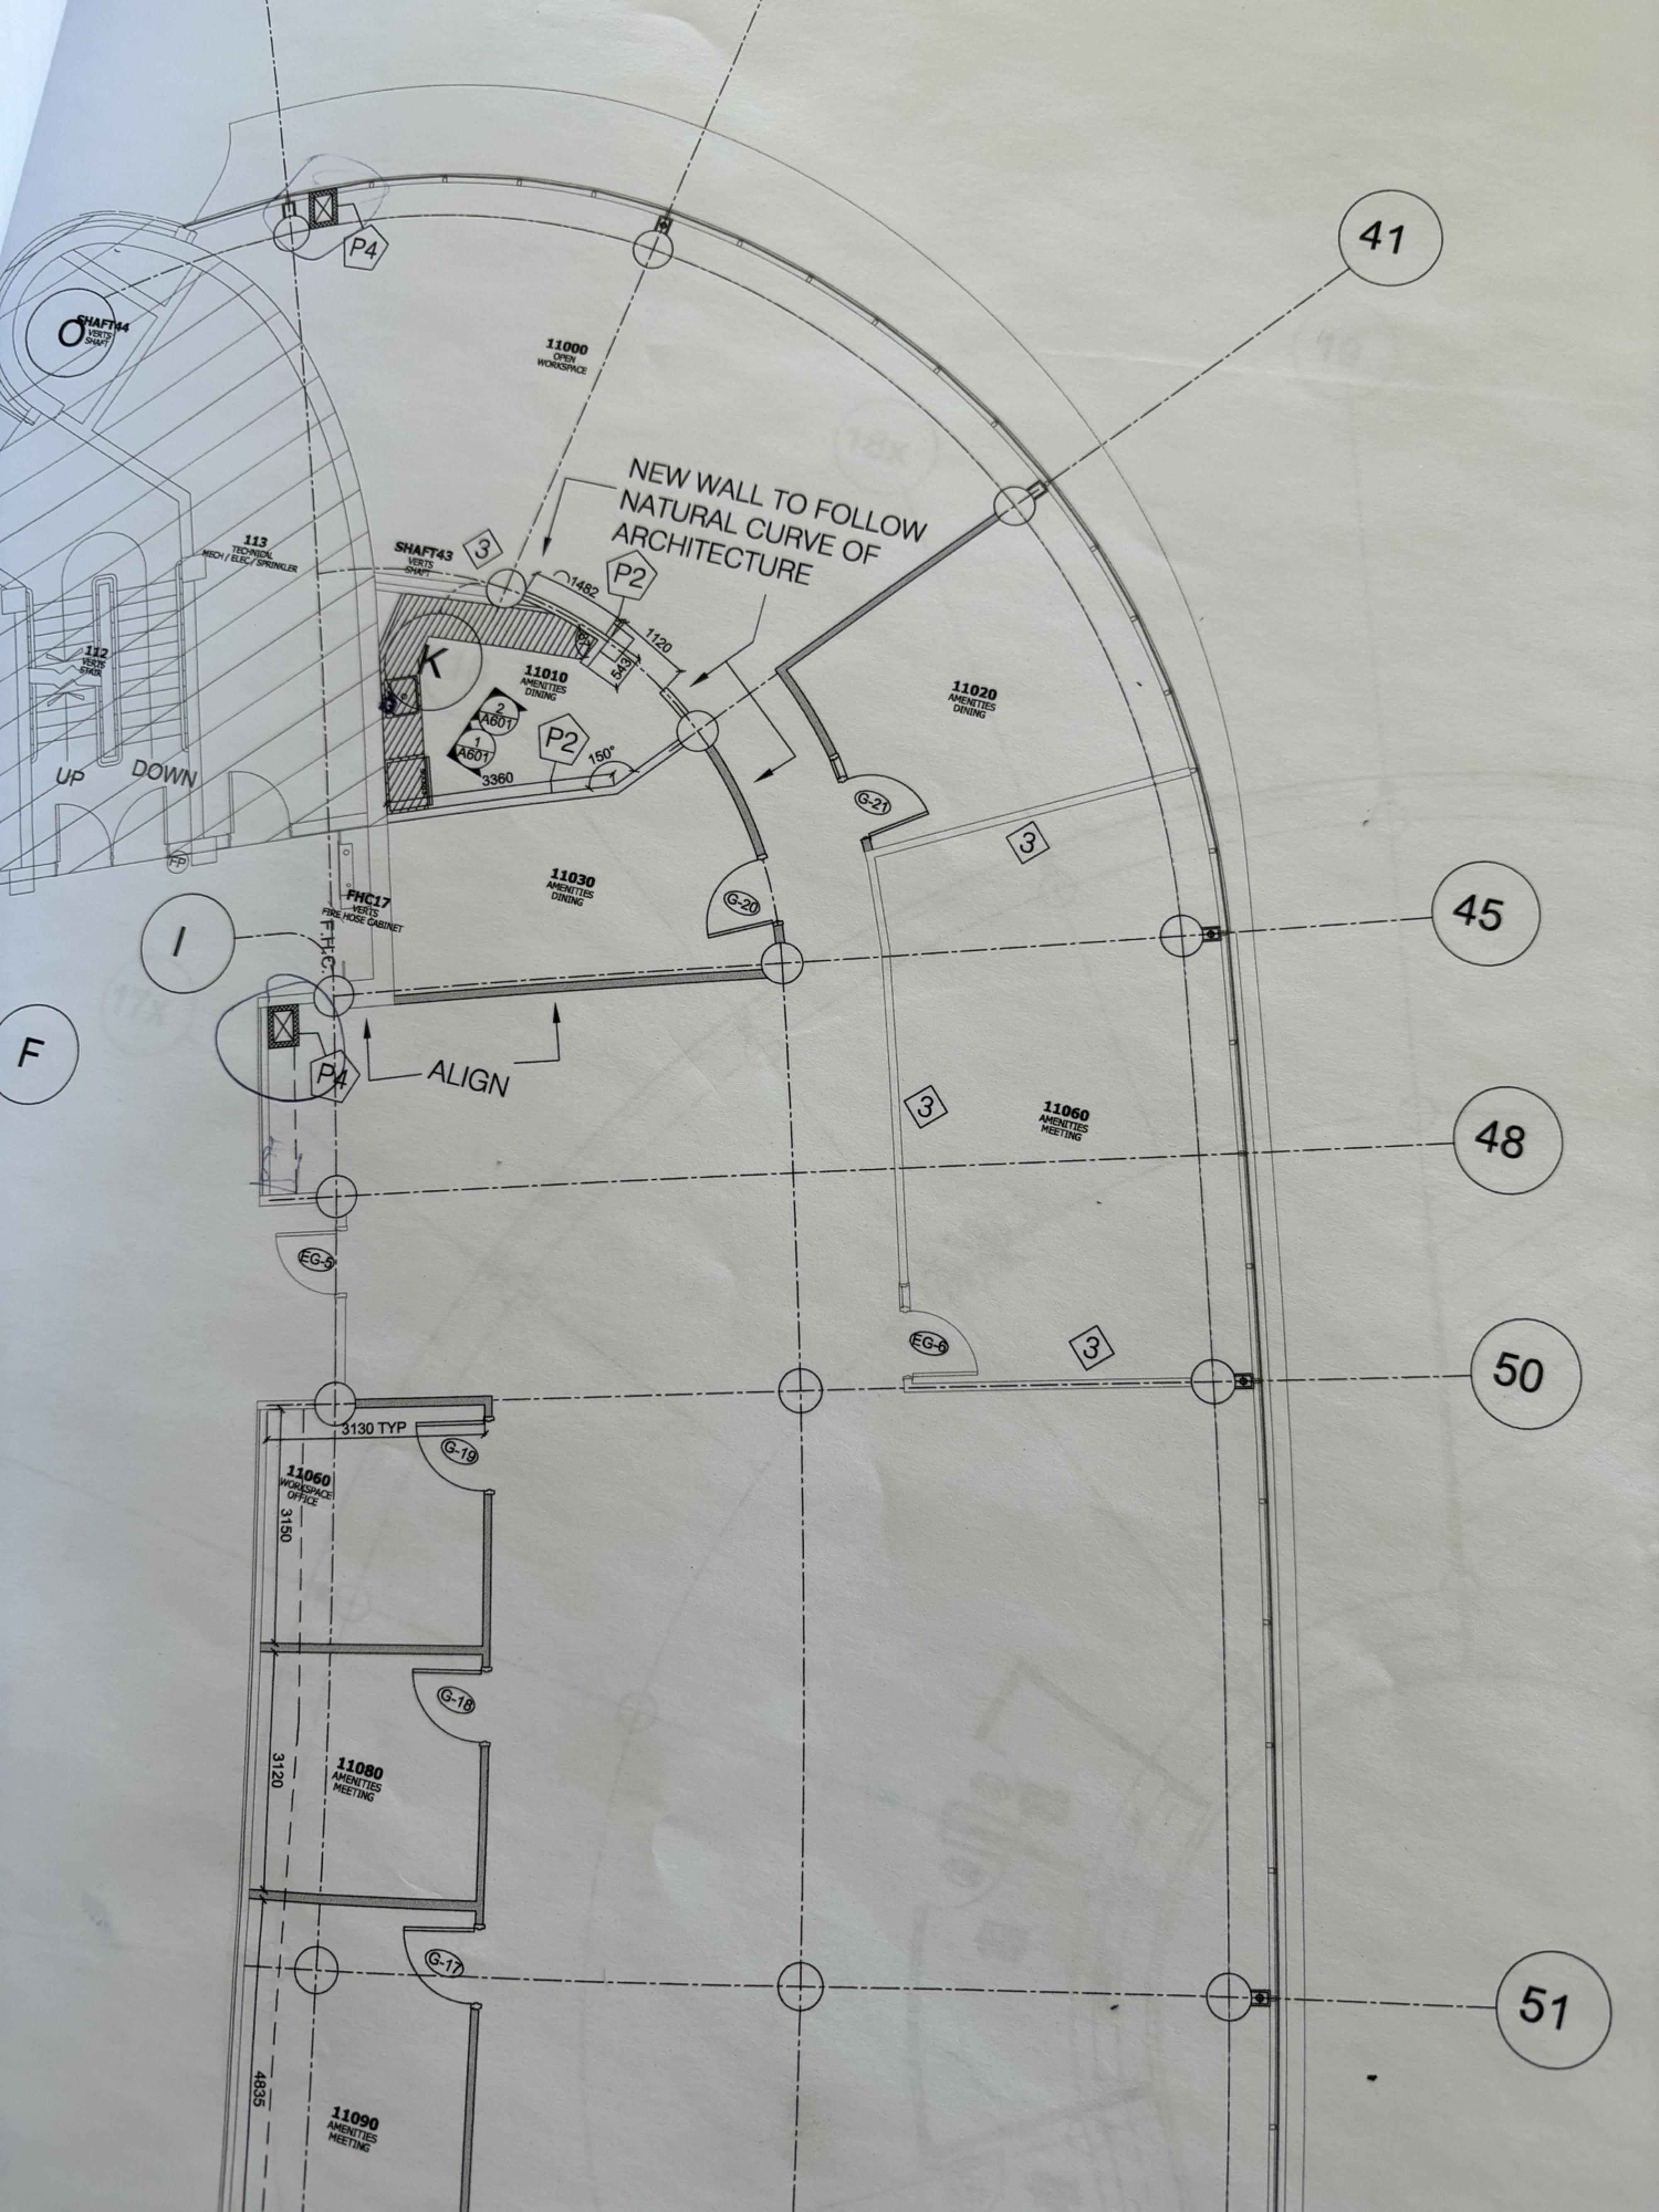
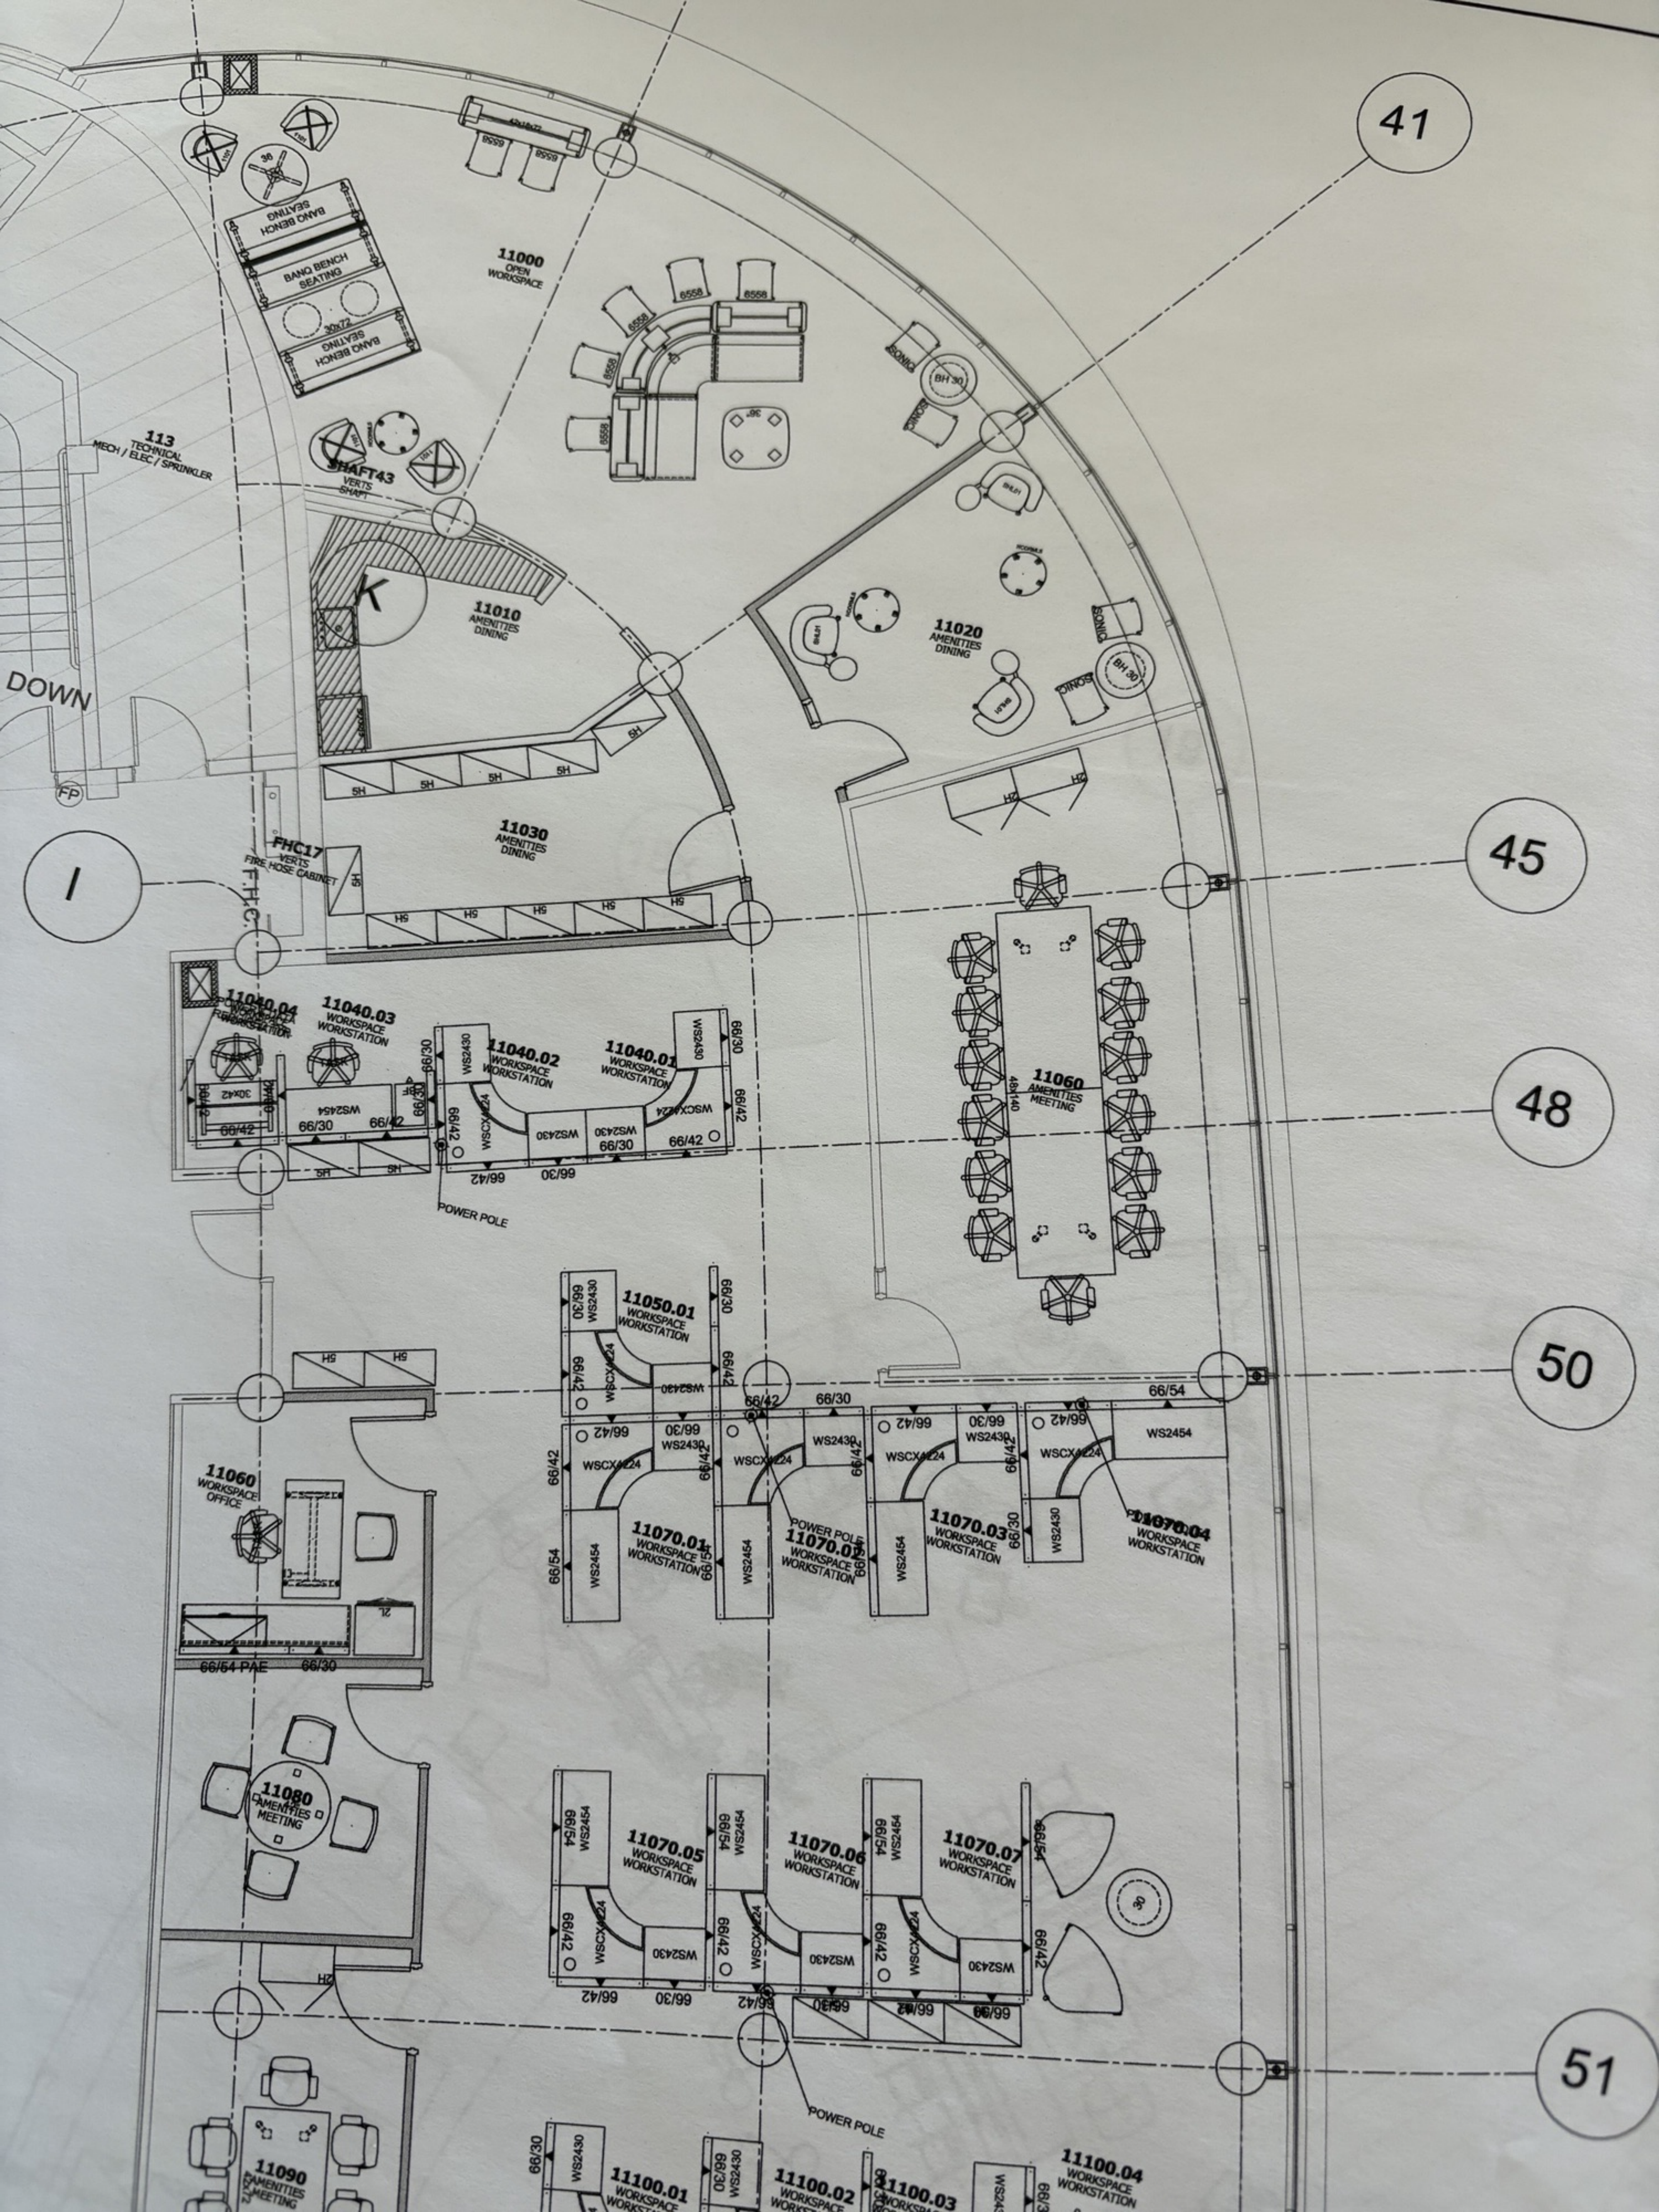
1st Floor

Ground floor chilled water supply main riser to P1:

Location is different from mechanical to architectural. Both suggested locations are above structure concrete caps which we're told can not be cored through. Please advise to where a new location is for the chilled line to penetrate the floor and for us to tie into the appropriate services in P1 level. The suggested location to where we are supposed to tie into the chilled mains is above a separation wall between the staff washrooms and the staff lunch room which is dry walled ceiling. Space is limited in ceiling space due to existing services as well. (Duct work, etc.)

1. Ground Floor: Please send us a sketch showing multiple proposed locations for the chilled water riser so that the Furniture Team, Structural, Architect can review and comment.
2. 2nd Floor: Please send us a sketch showing multiple proposed locations for the chilled water riser so that the Furniture Team, Structural, Architect can review and comment.
2. 3rd Floor: Please send us a sketch showing alternate location of the chilled water main routing for our review.
