REQUEST FOR INFORMATION

Project Name: York Region Admin., Package D Renovation

REFERENCE: [Ground, 2nd & 3rd Floor Chilled Water Main](#)

Ground, 2nd & 3rd floor chilled water main

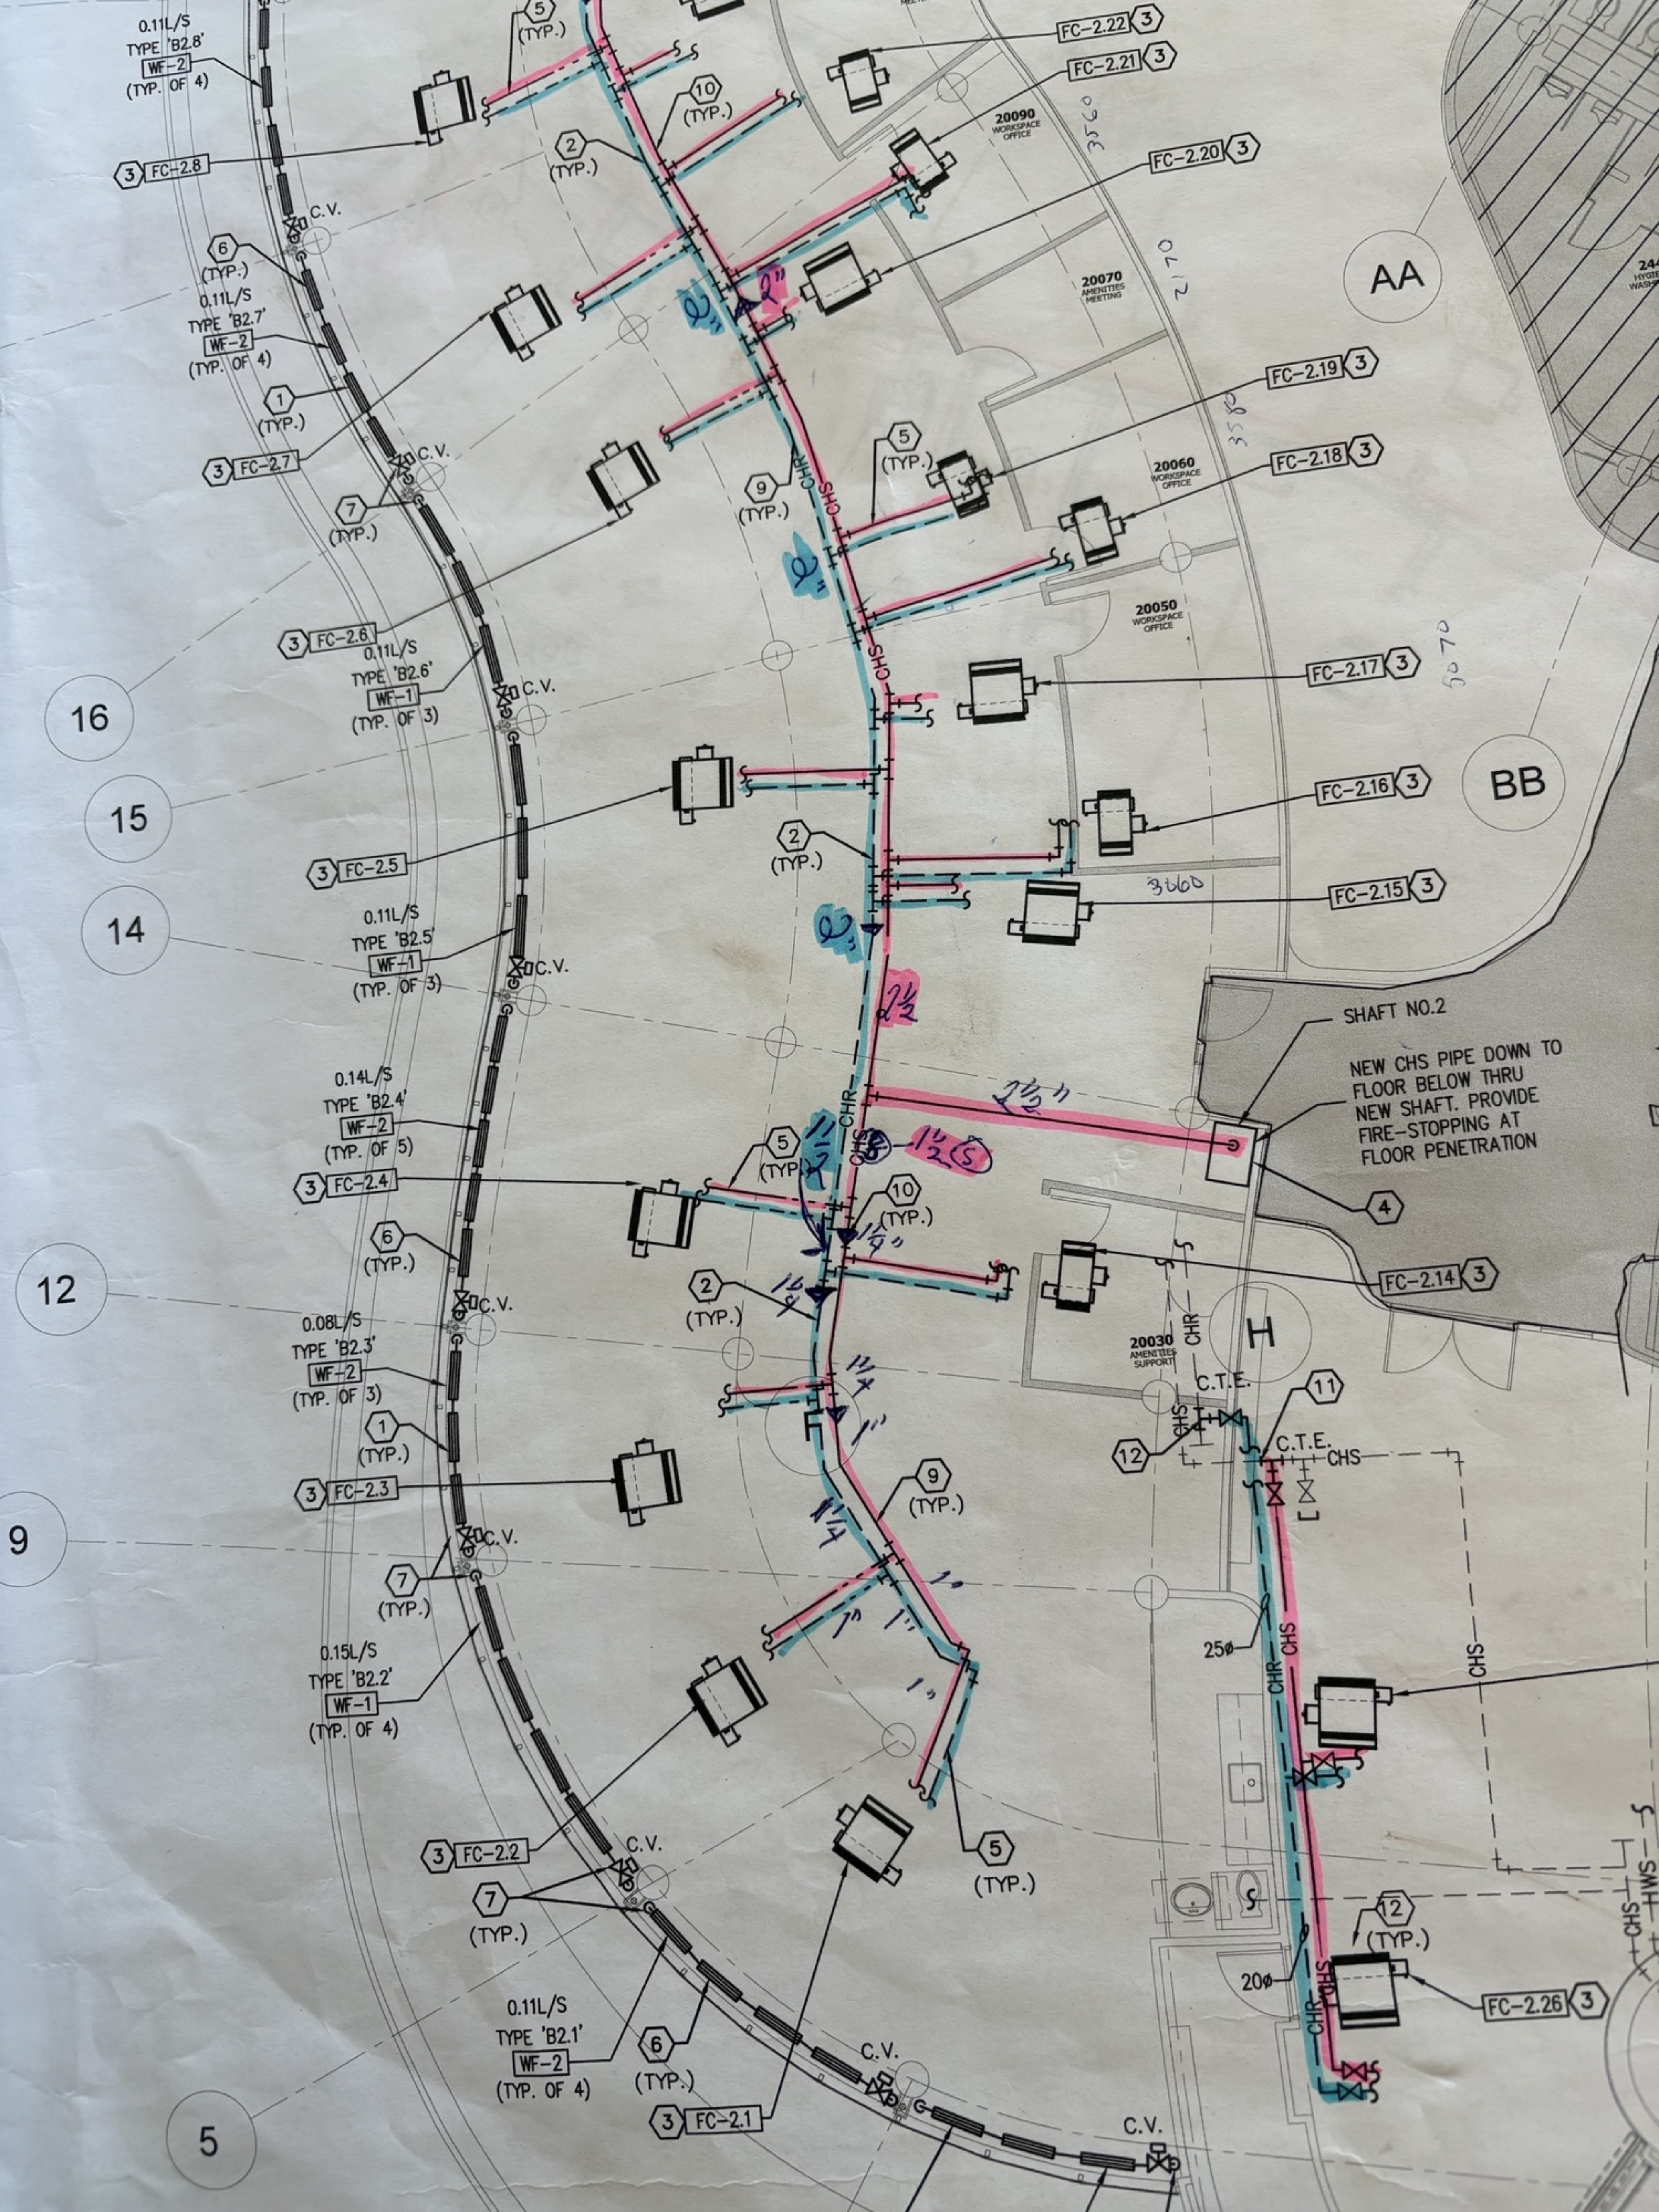
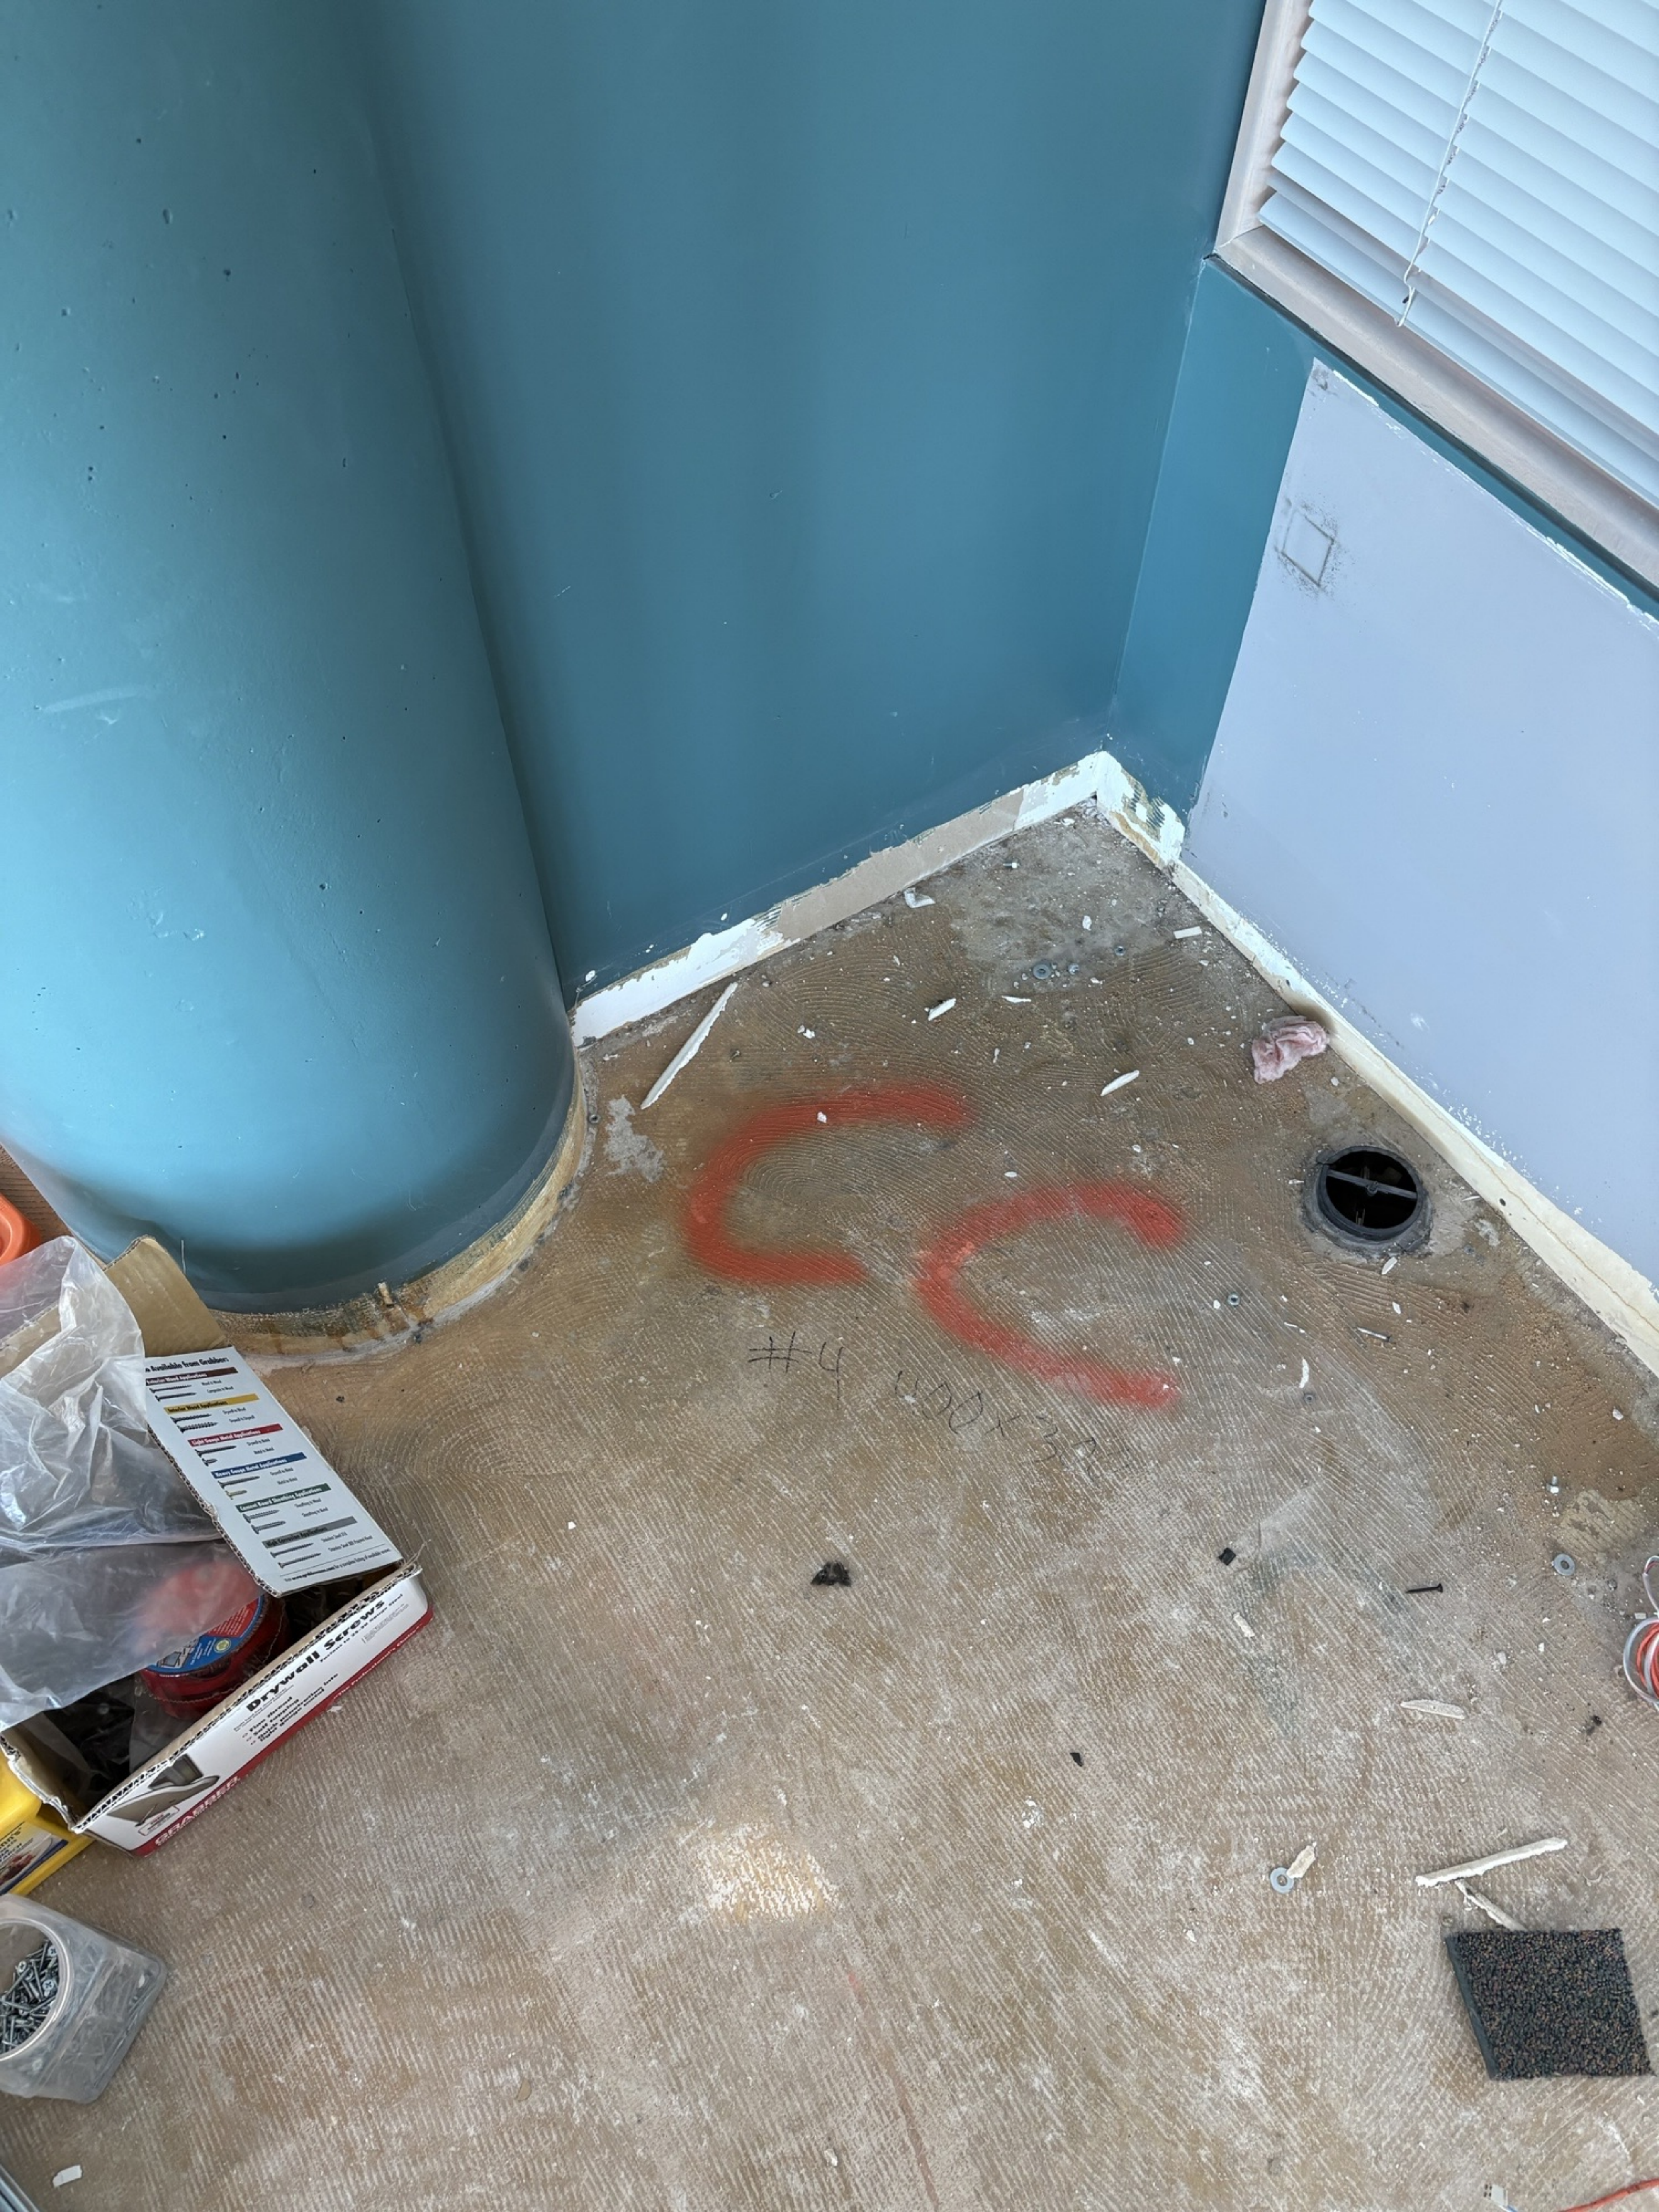
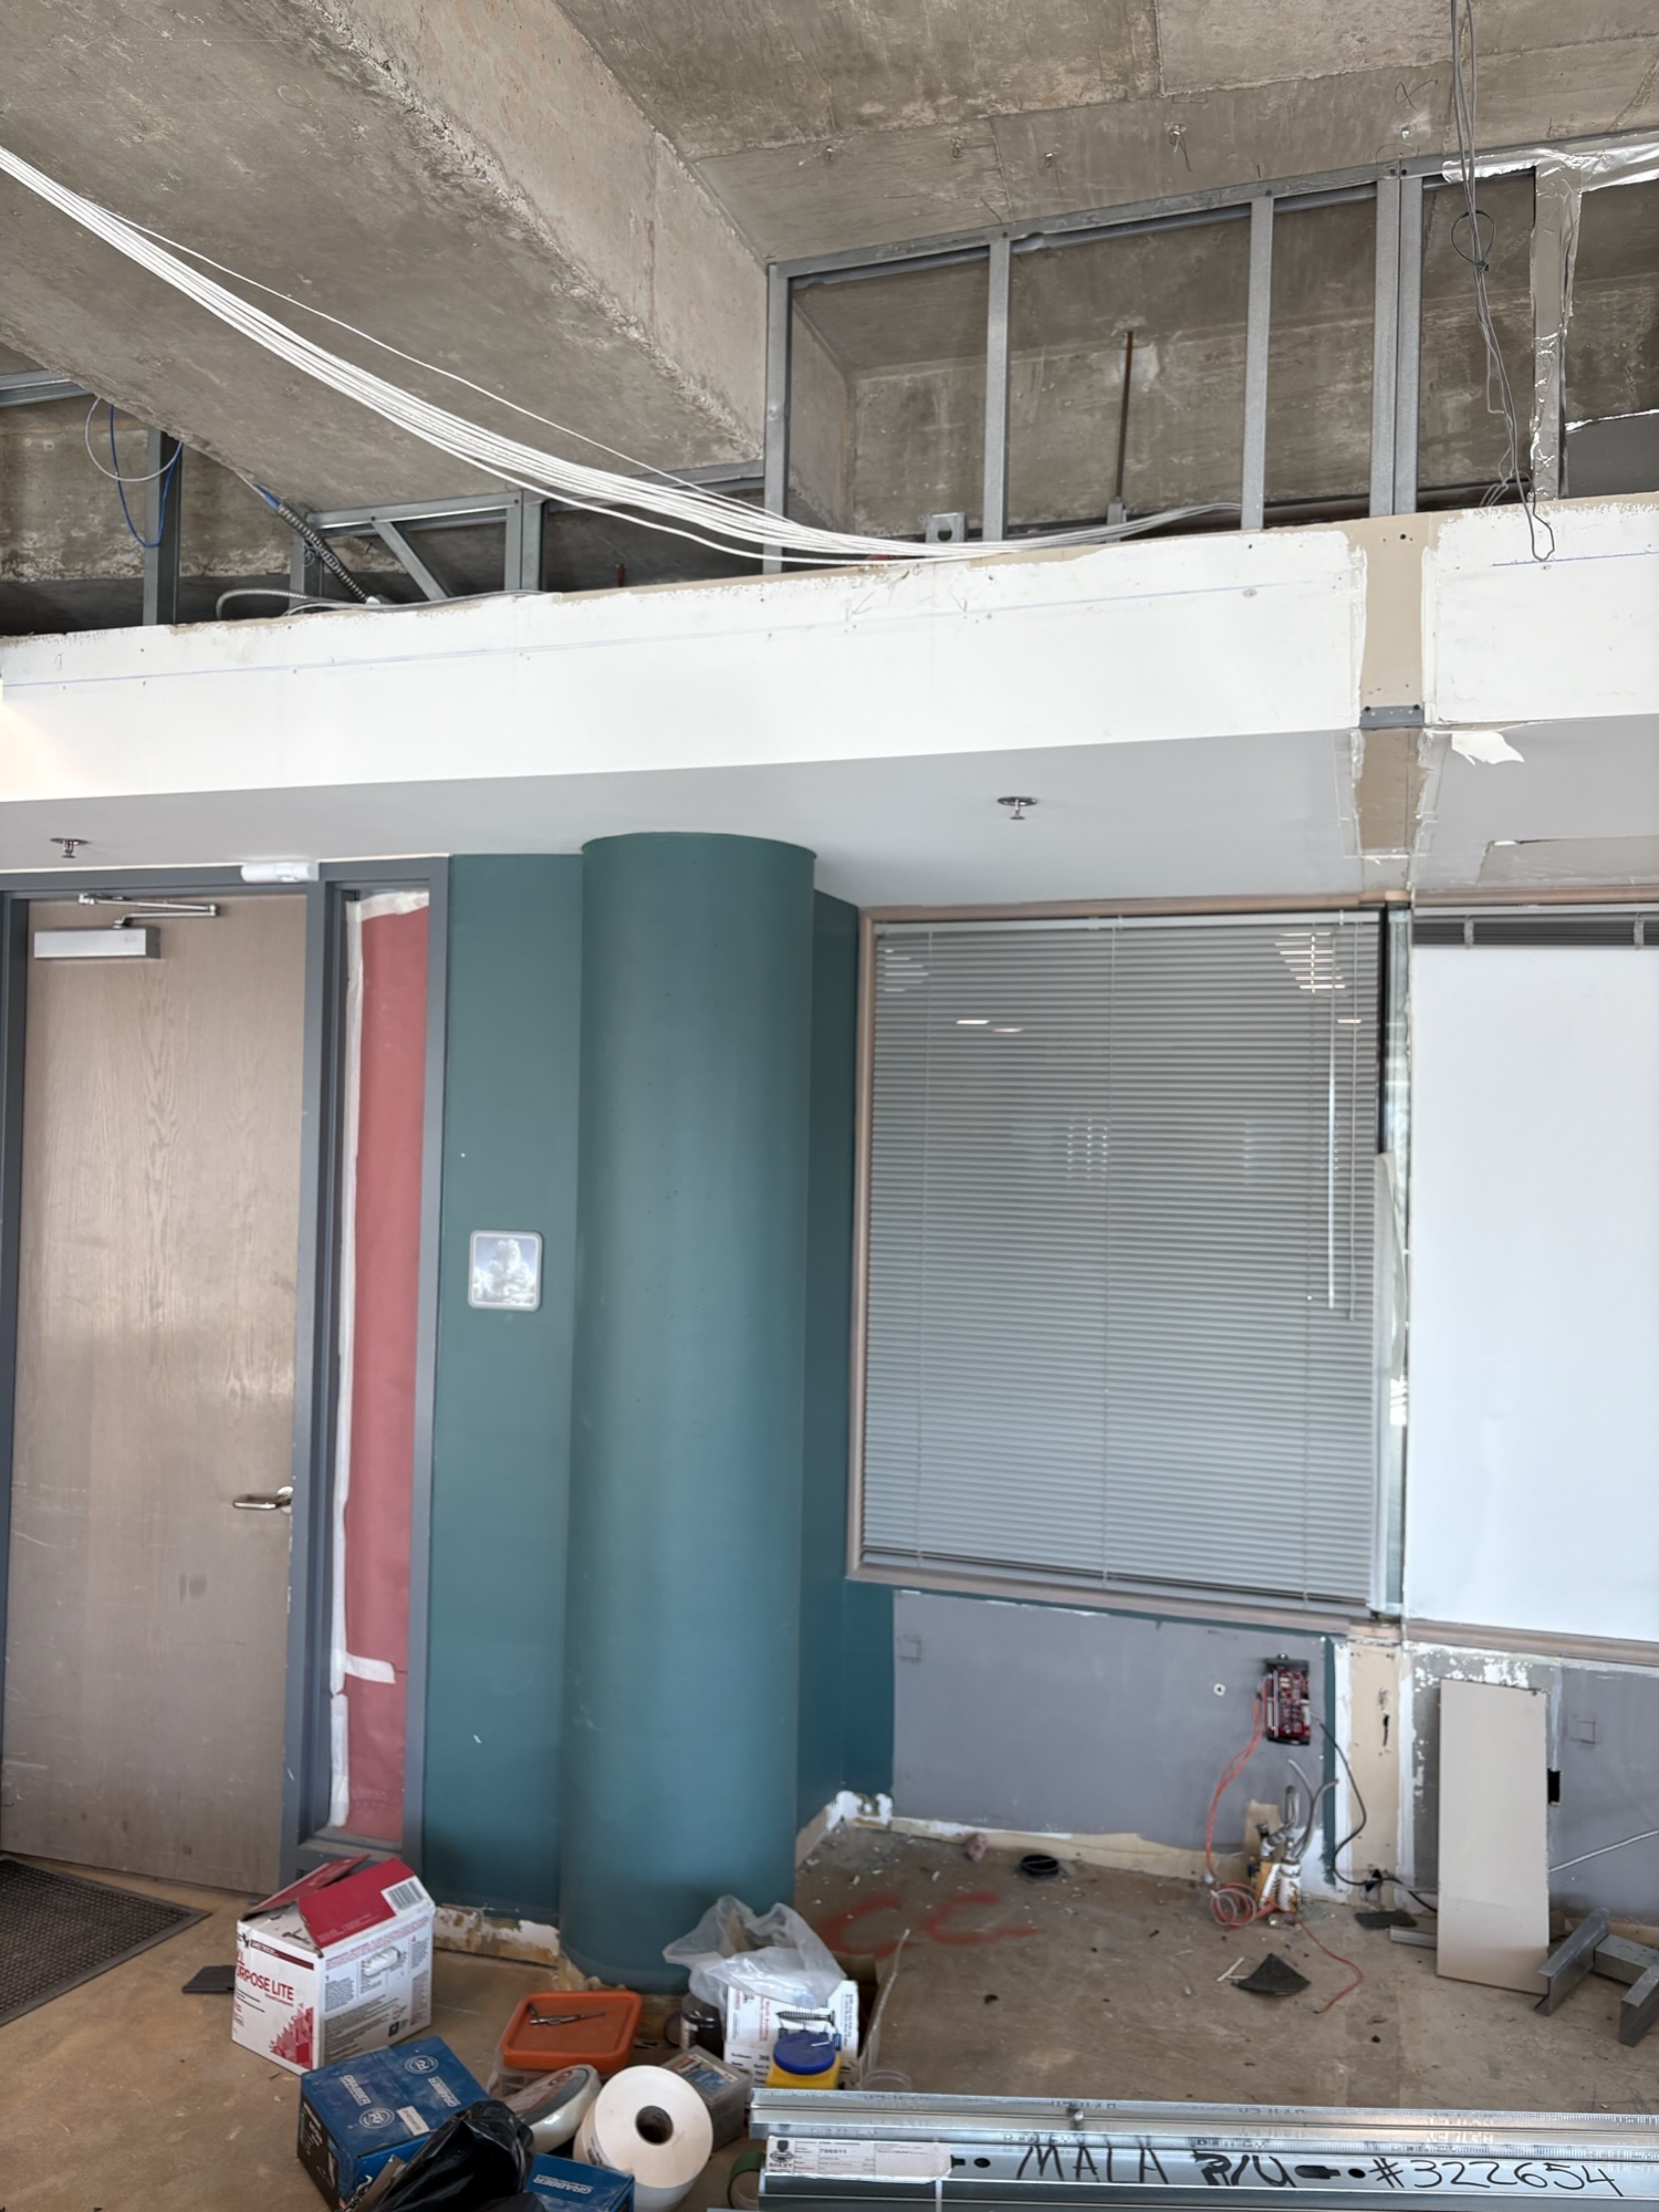
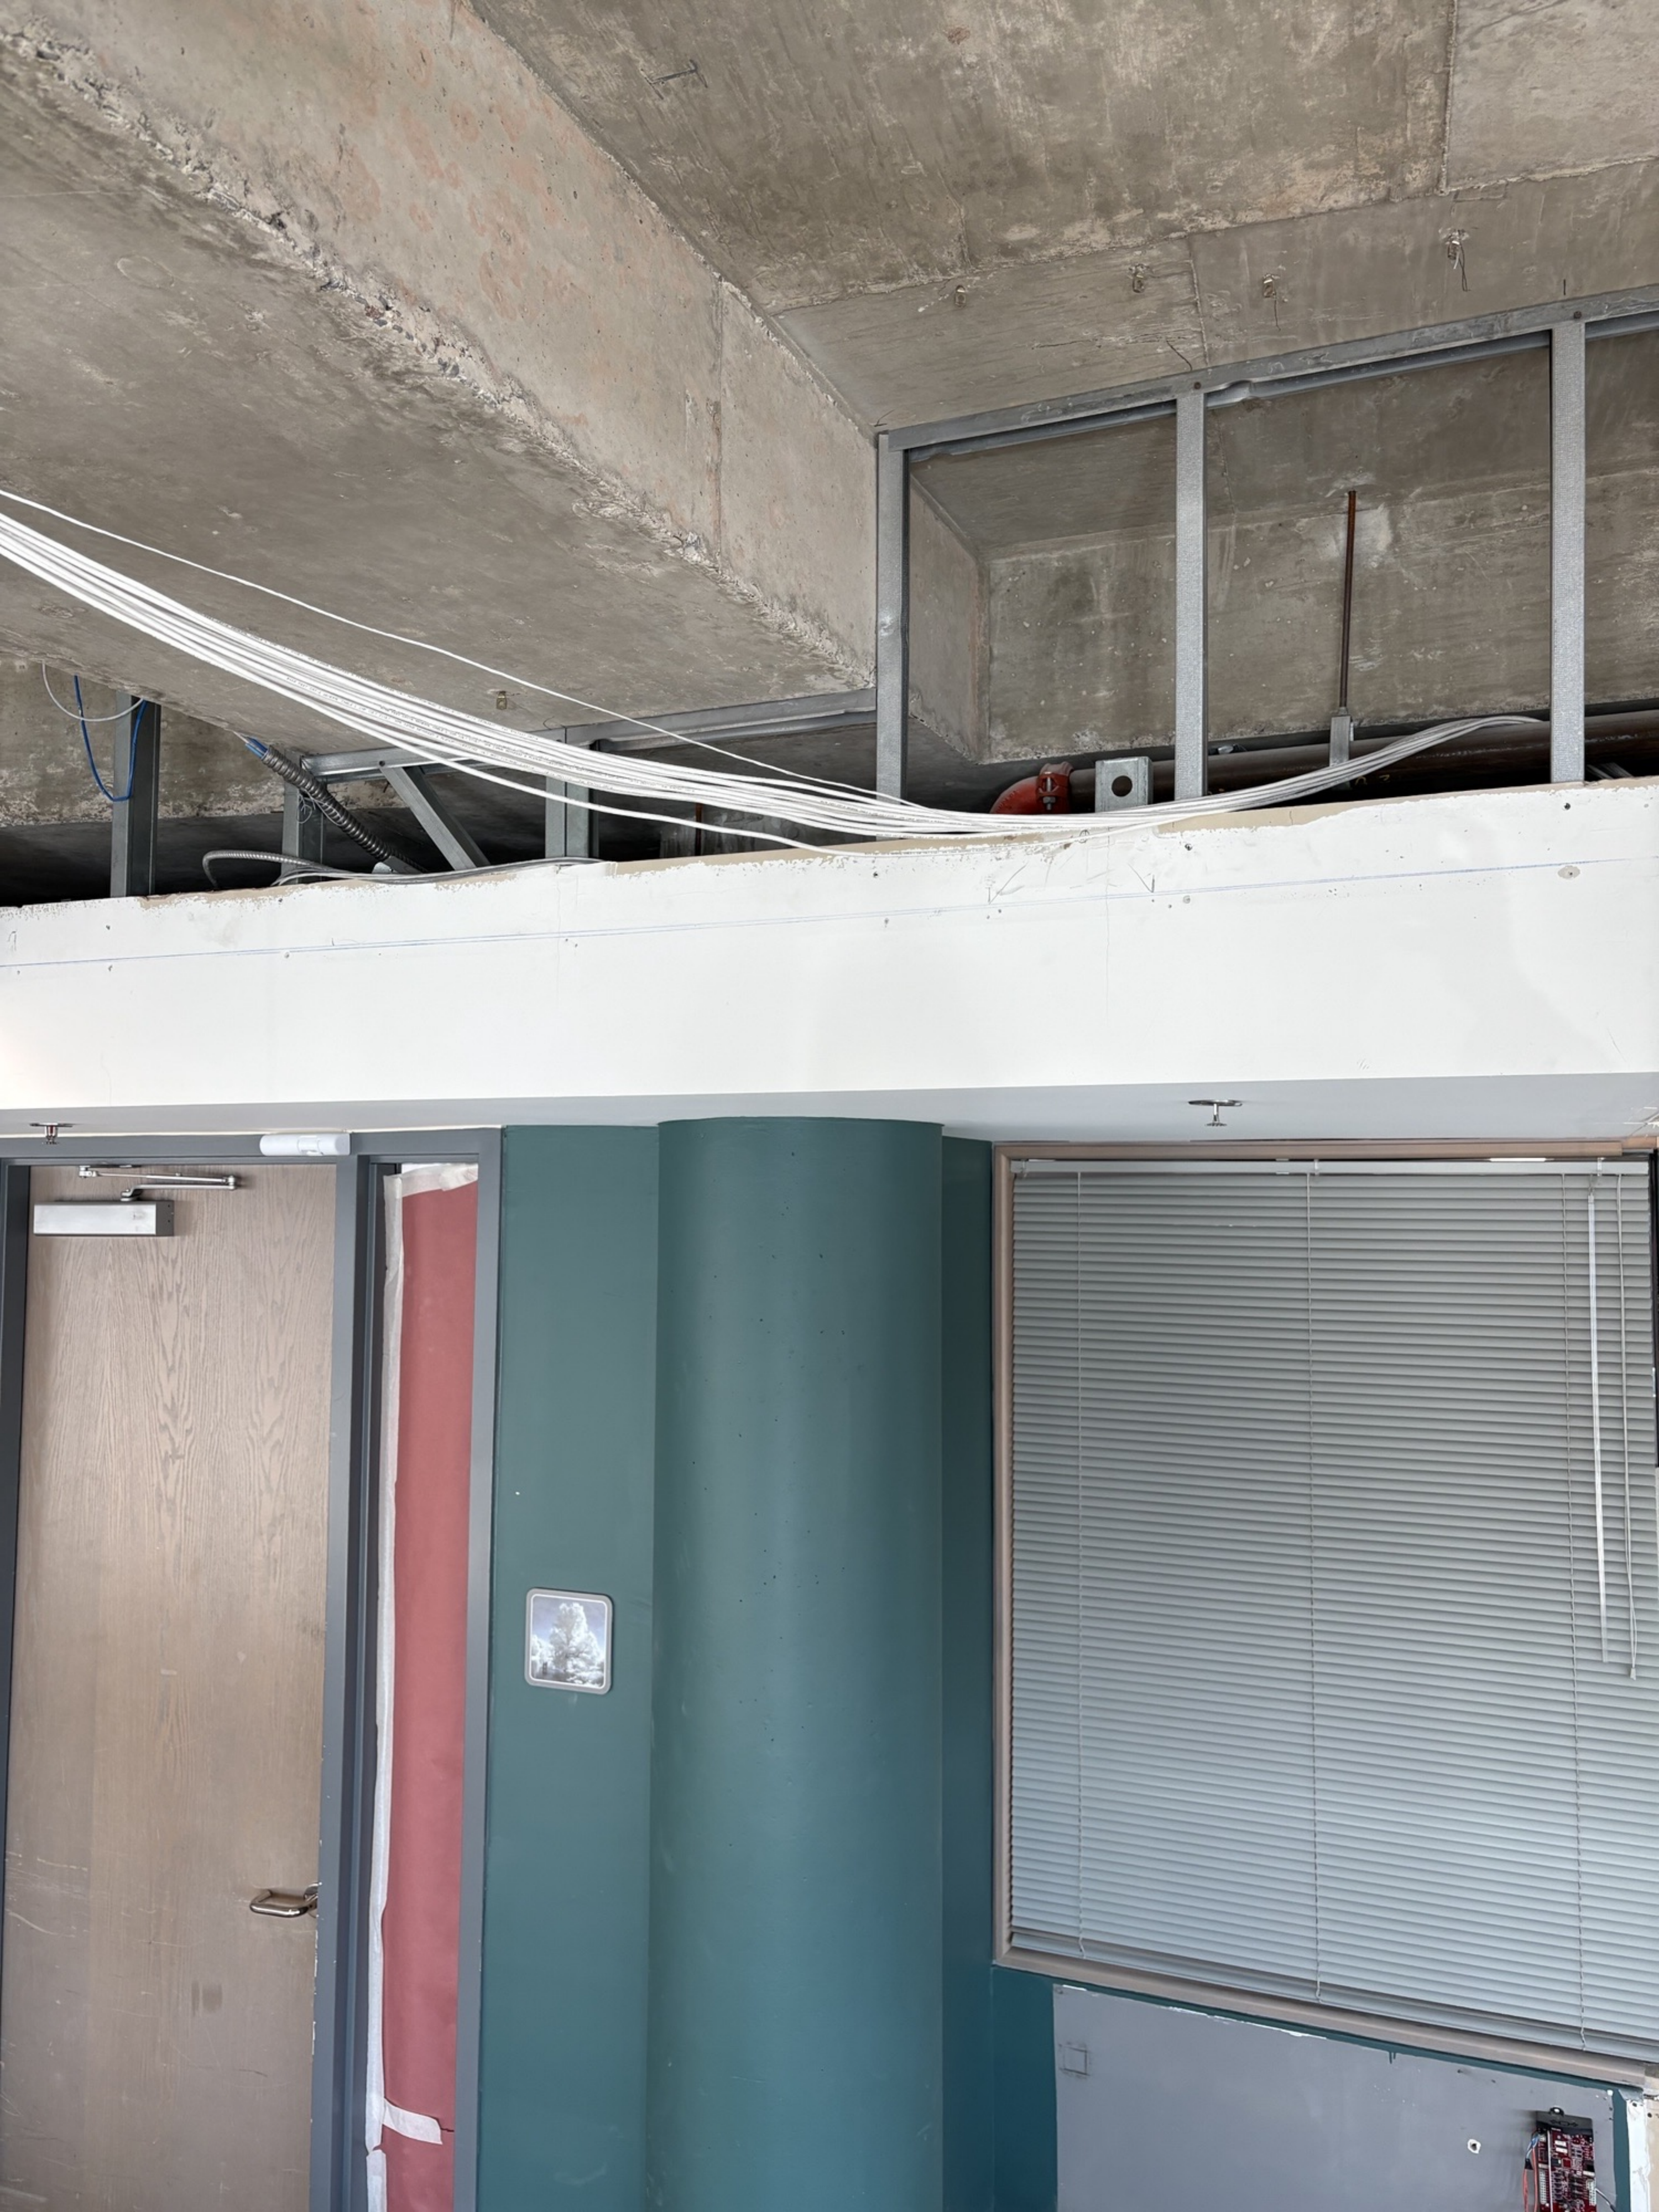
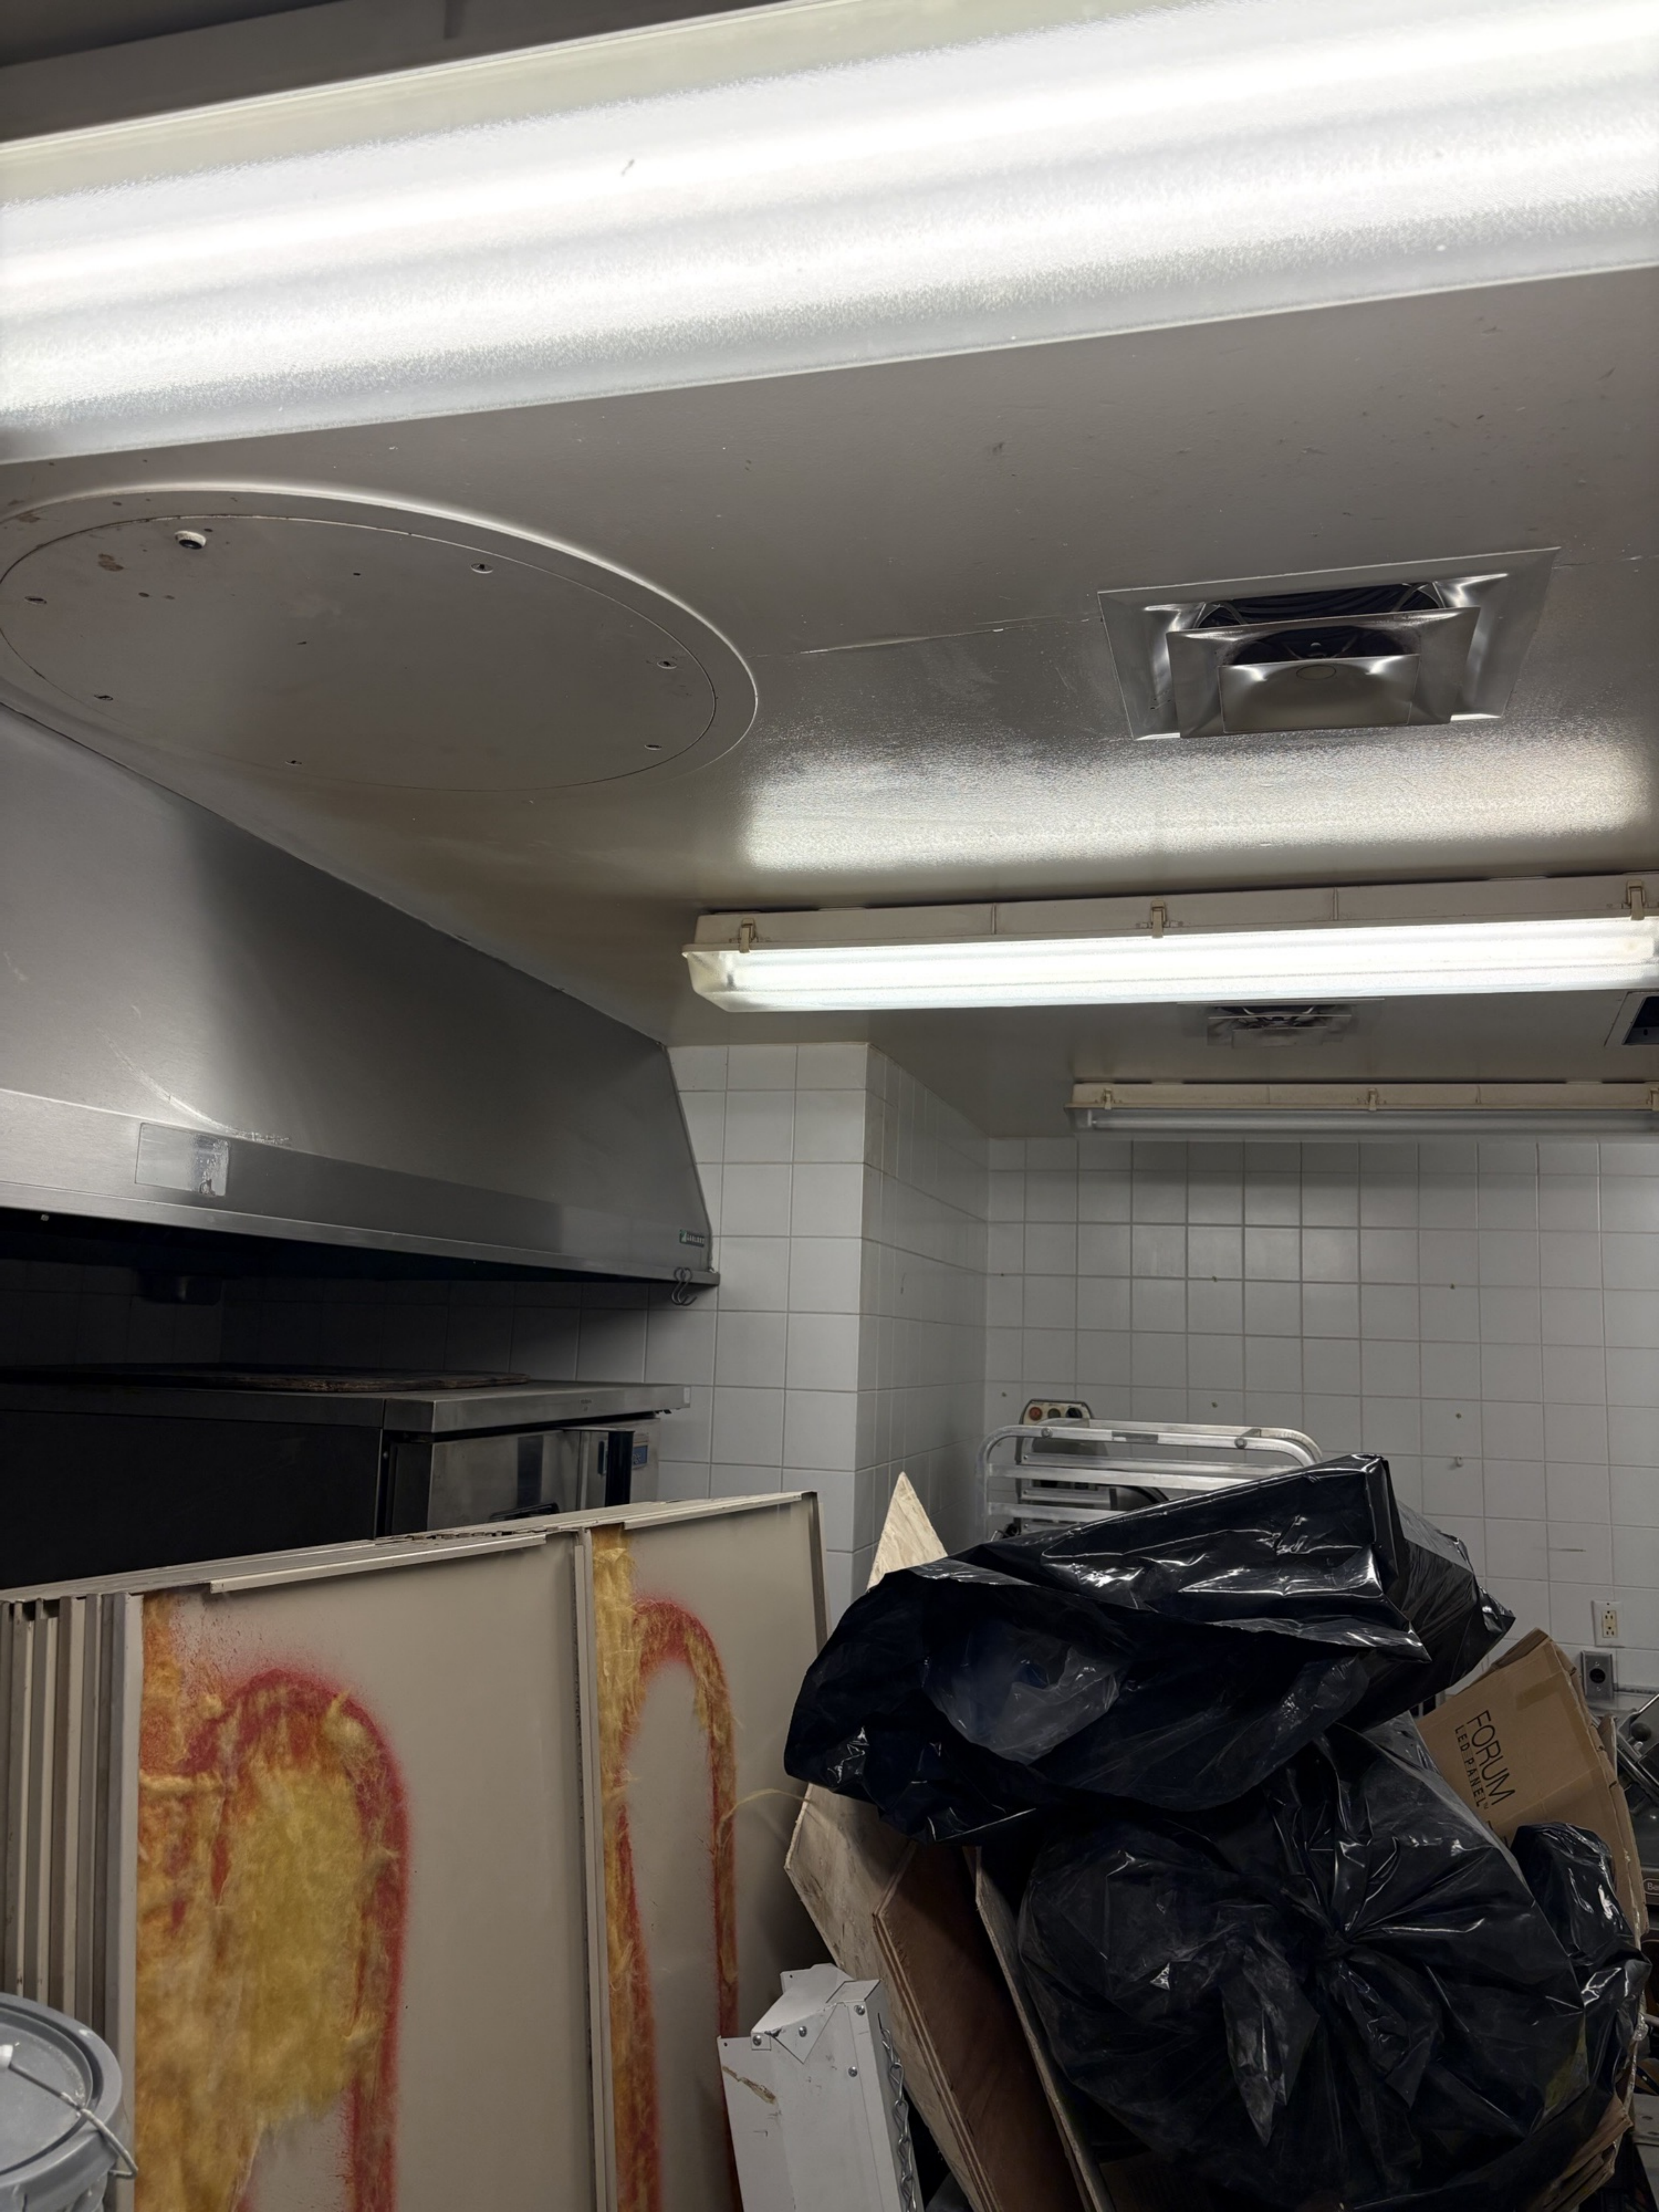
2nd Floor

2nd floor:

The same issue looks to be occurring. The location where it goes through the floor is near a column. Below on the ground floor it's in the old cafeteria which is blocked in and tiled. Its not possible see the column on the ground floor to confirm concrete cap underneath. Grid line #14

1. Ground Floor: Please send us a sketch showing multiple proposed locations for the chilled water riser so that the Furniture Team, Structural, Architect can review and comment.
2. 2nd Floor: Please send us a sketch showing multiple proposed locations for the chilled water riser so that the Furniture Team, Structural, Architect can review and comment.
2. 3rd Floor: Please send us a sketch showing alternate location of the chilled water main routing for our review.
