REQUEST FOR INFORMATION

Project Name: York Region Admin., Package D Renovation

REFERENCE: [Ground, 2nd & 3rd Floor Chilled Water Main](#)

Ground, 2nd & 3rd floor chilled water main

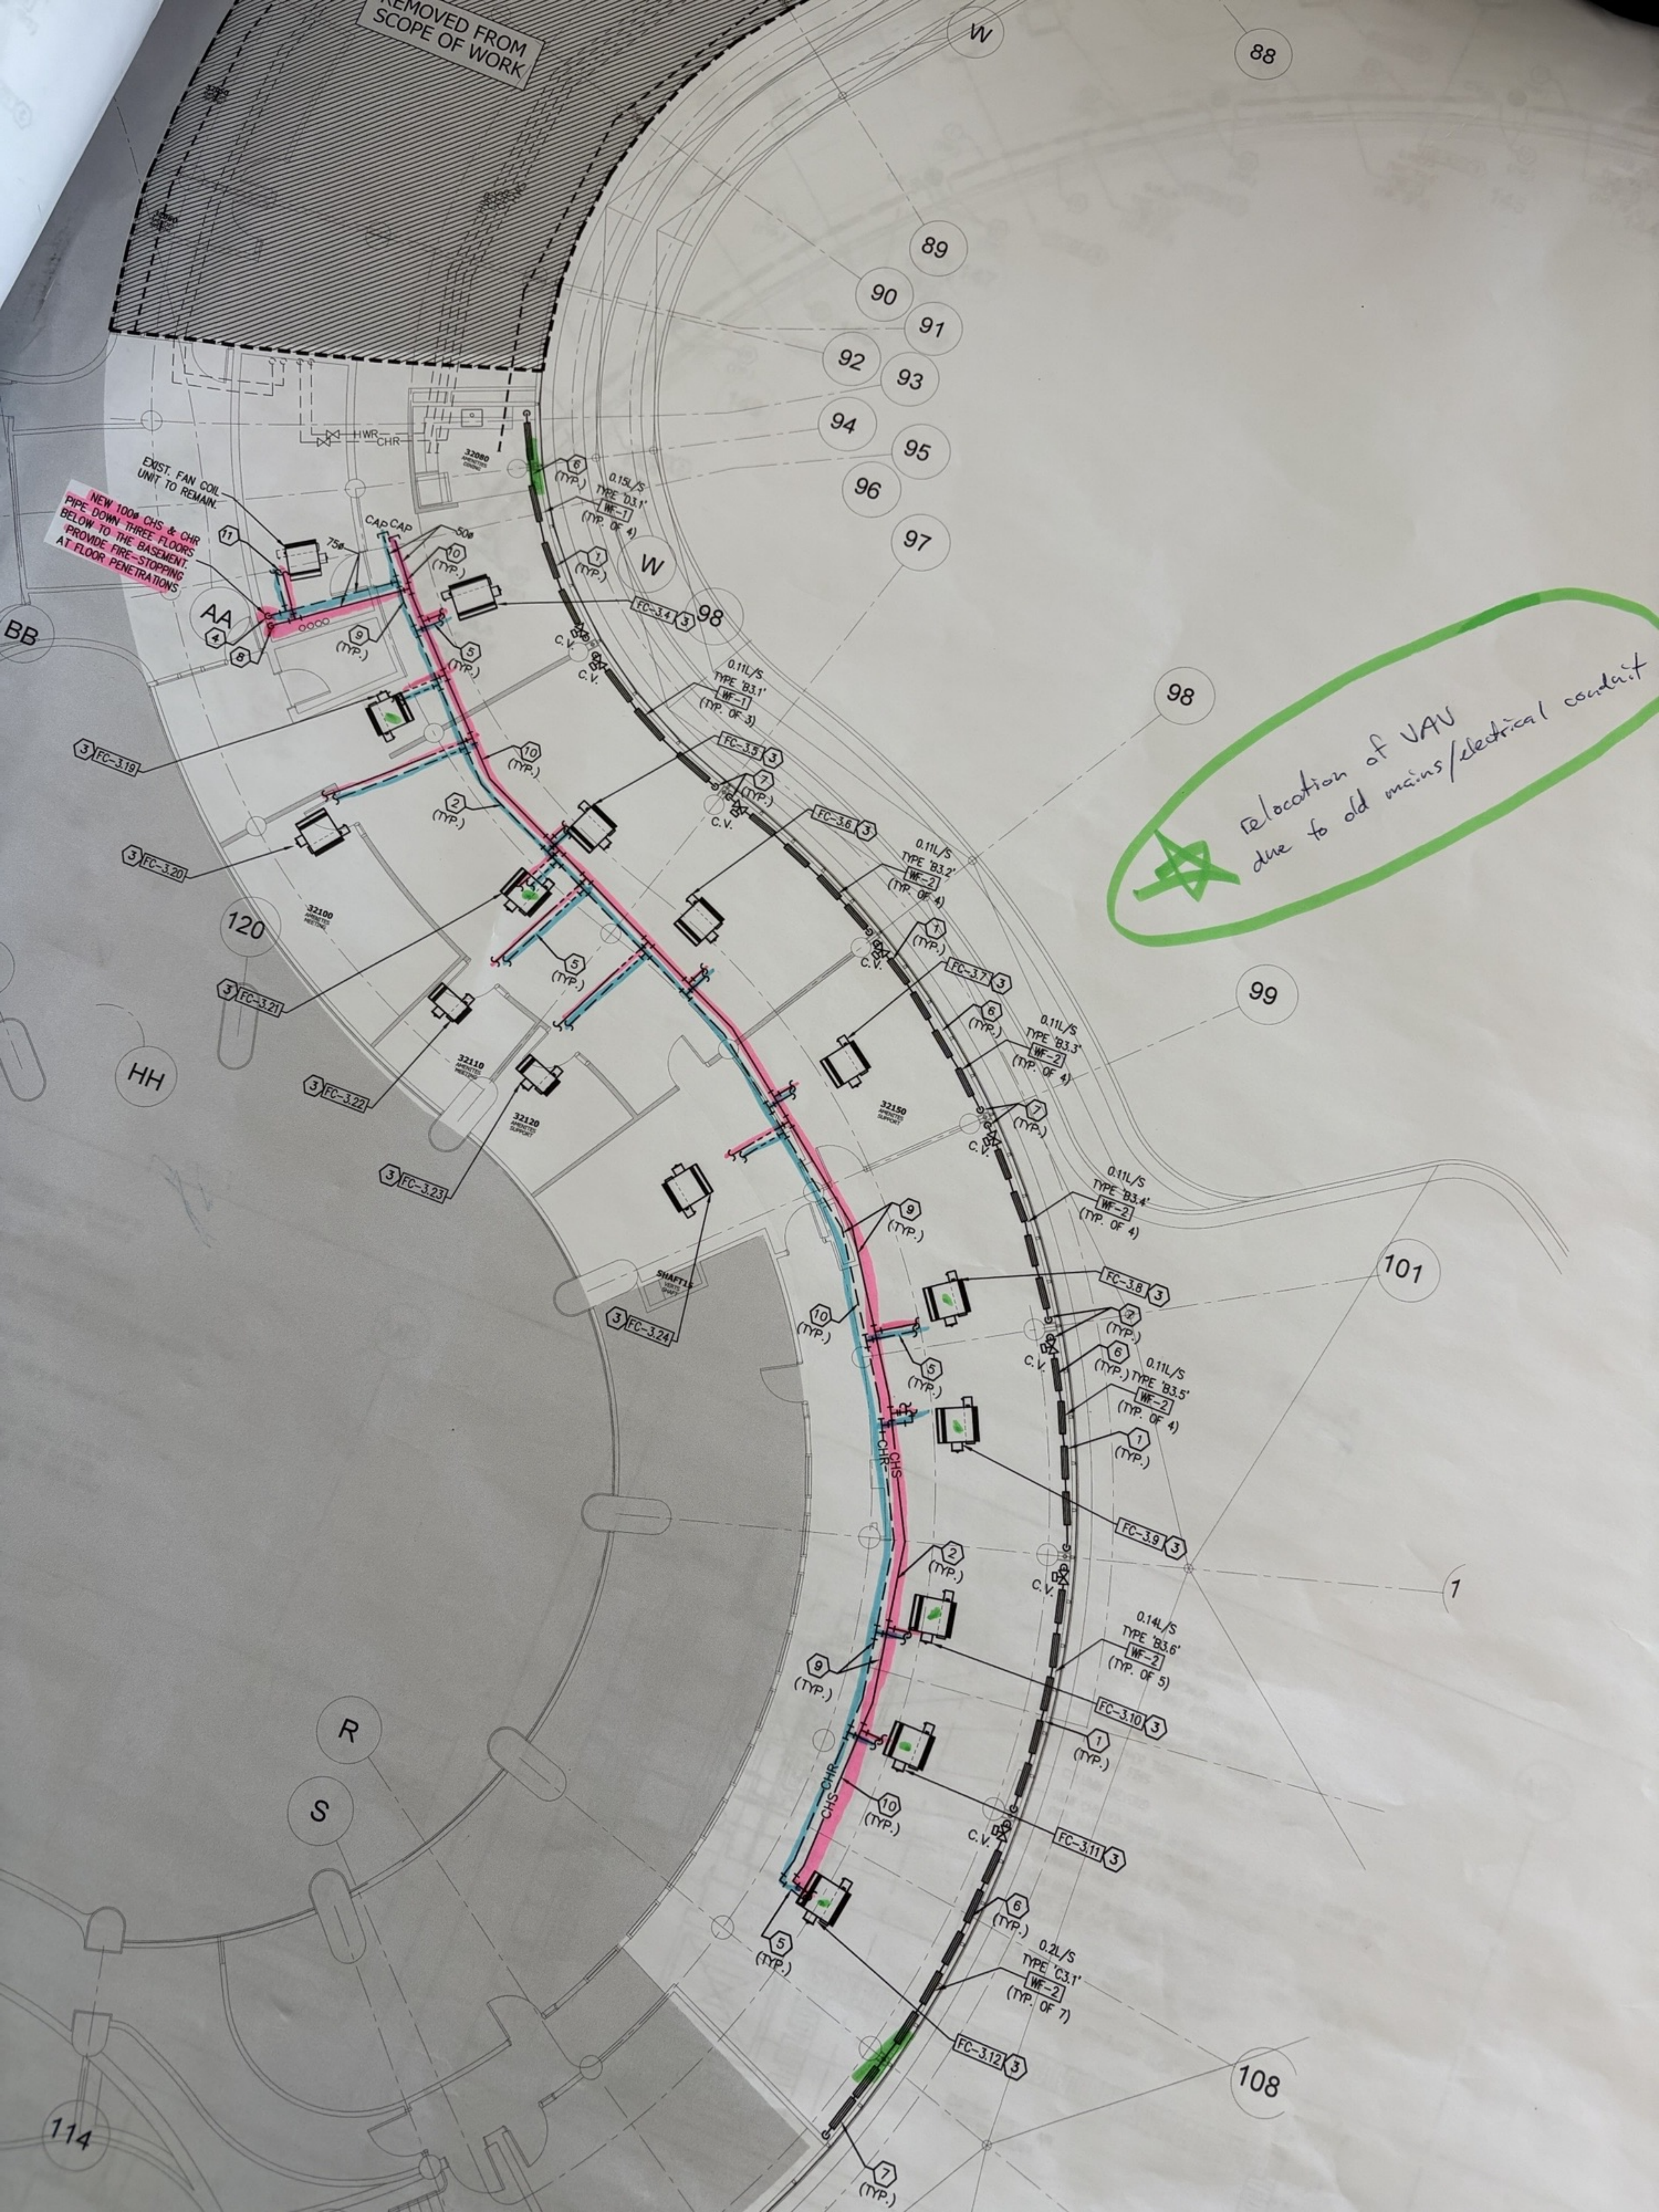
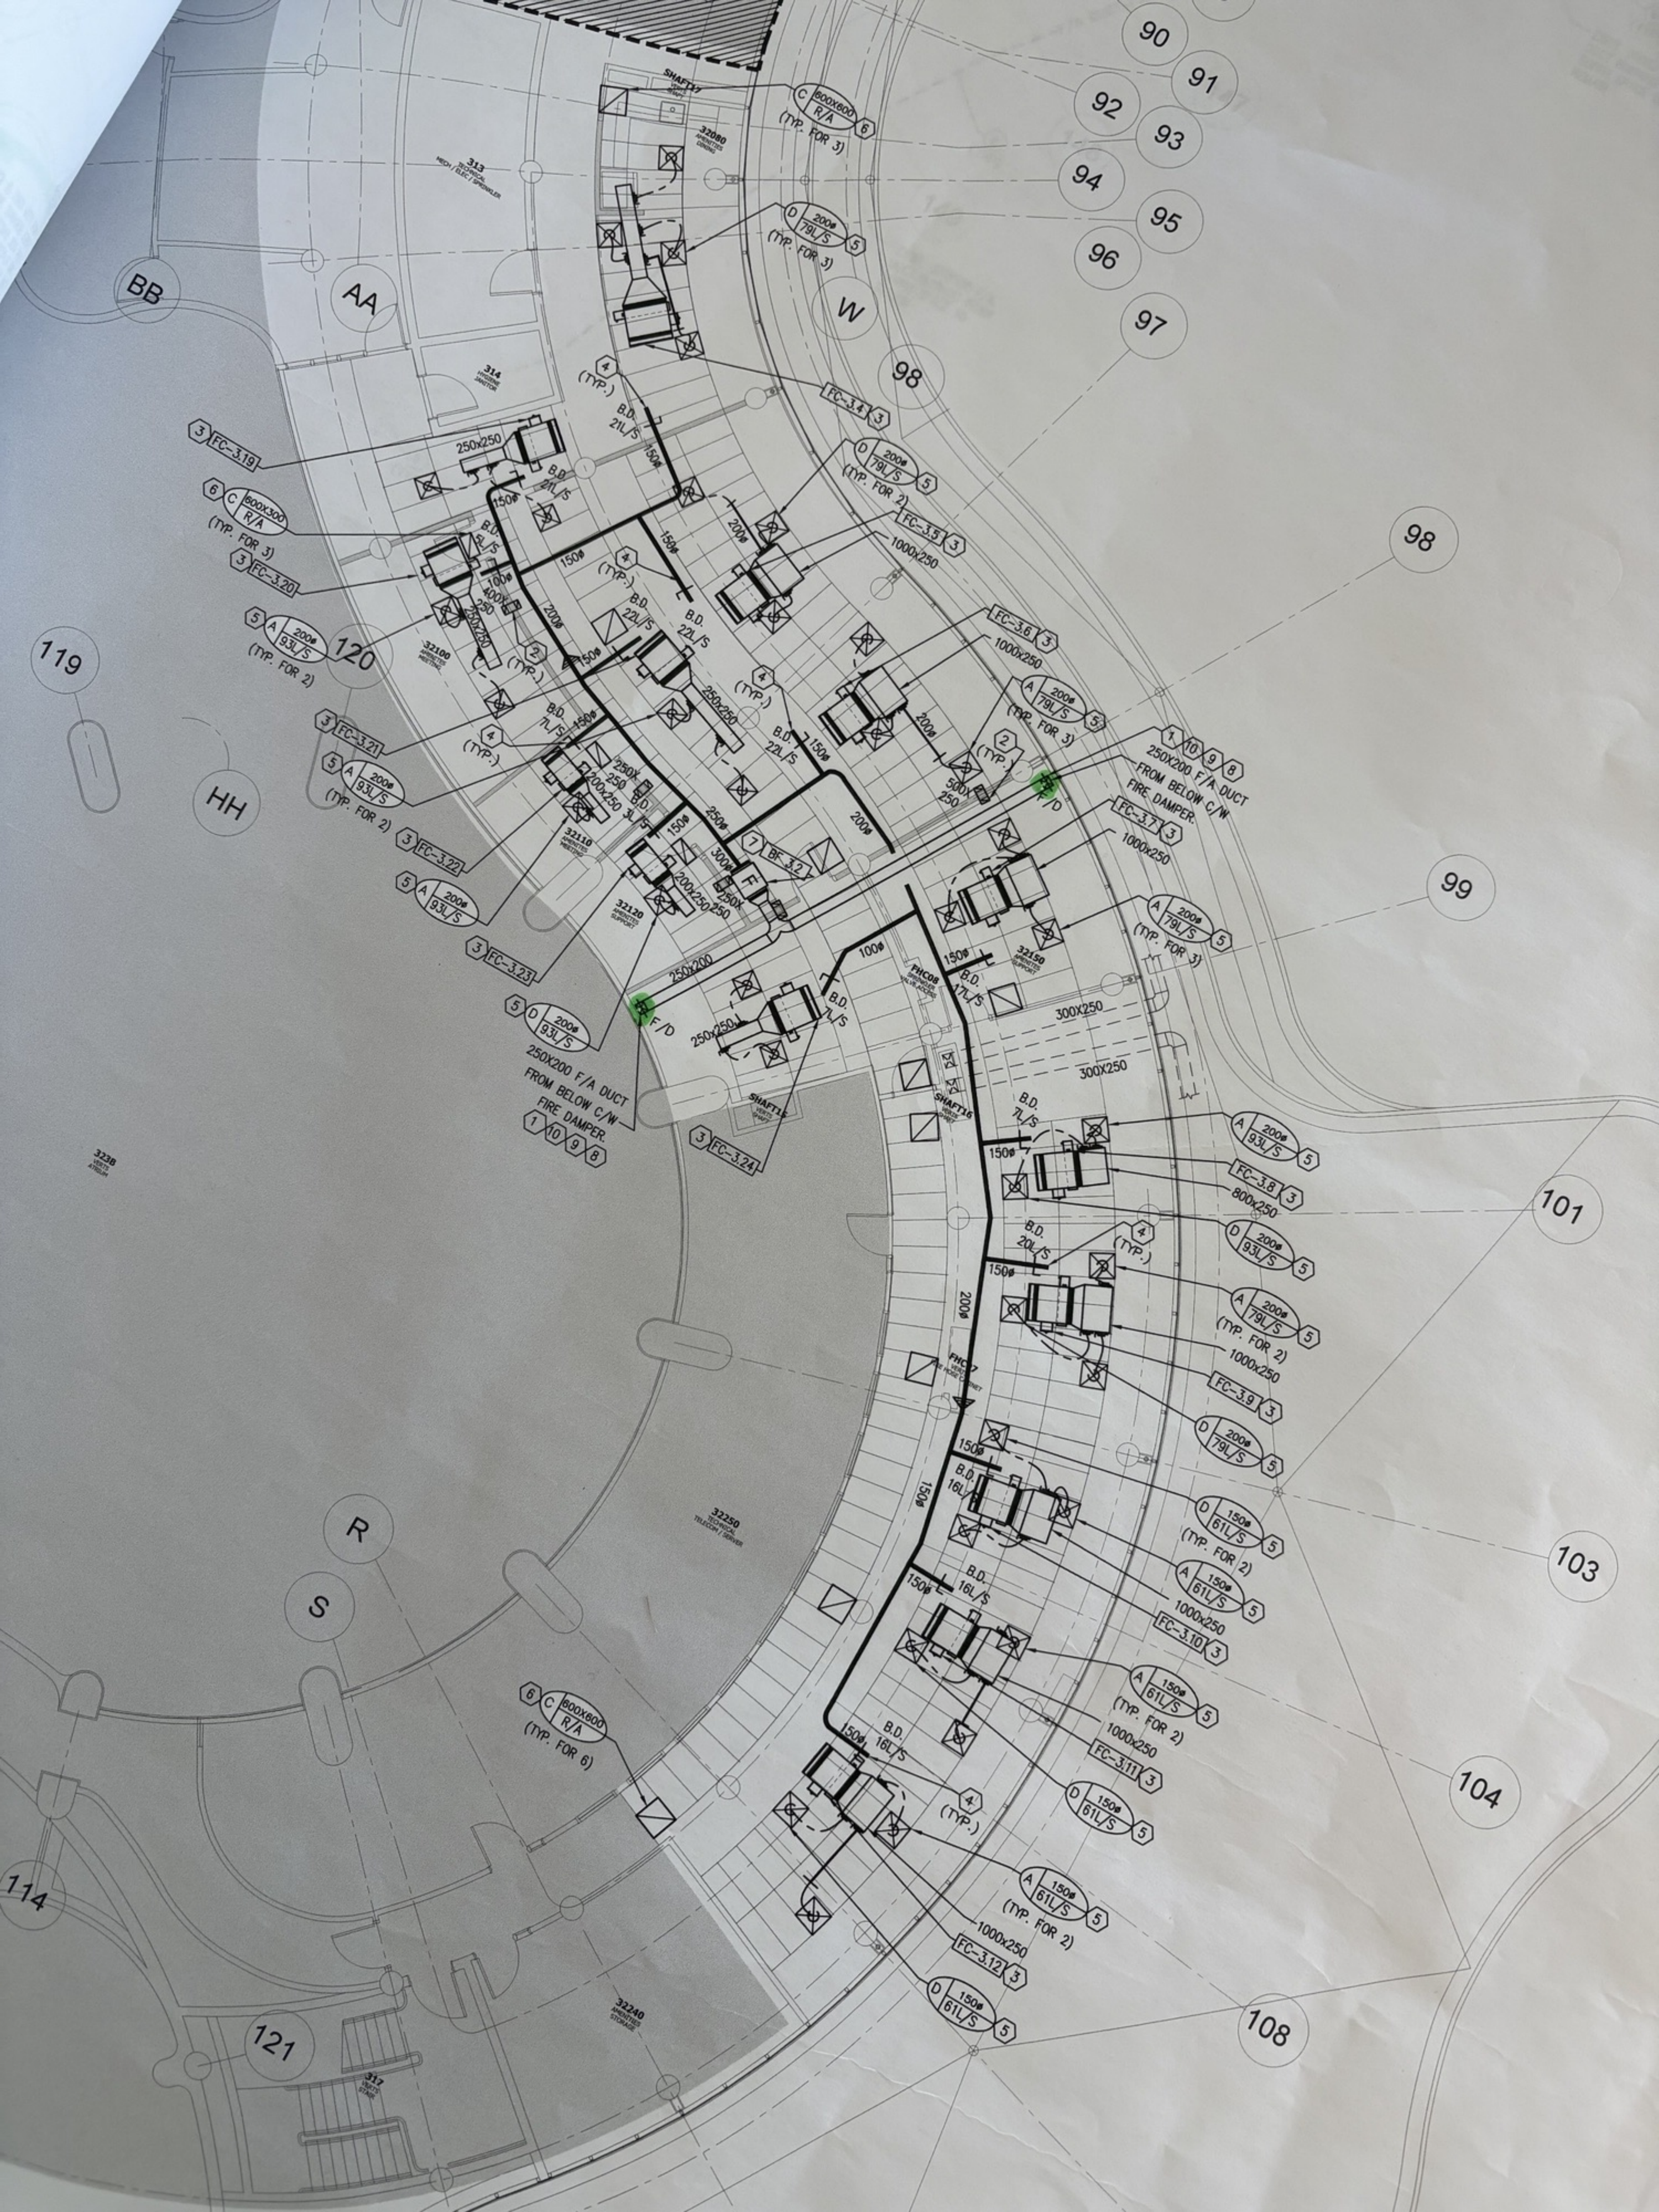
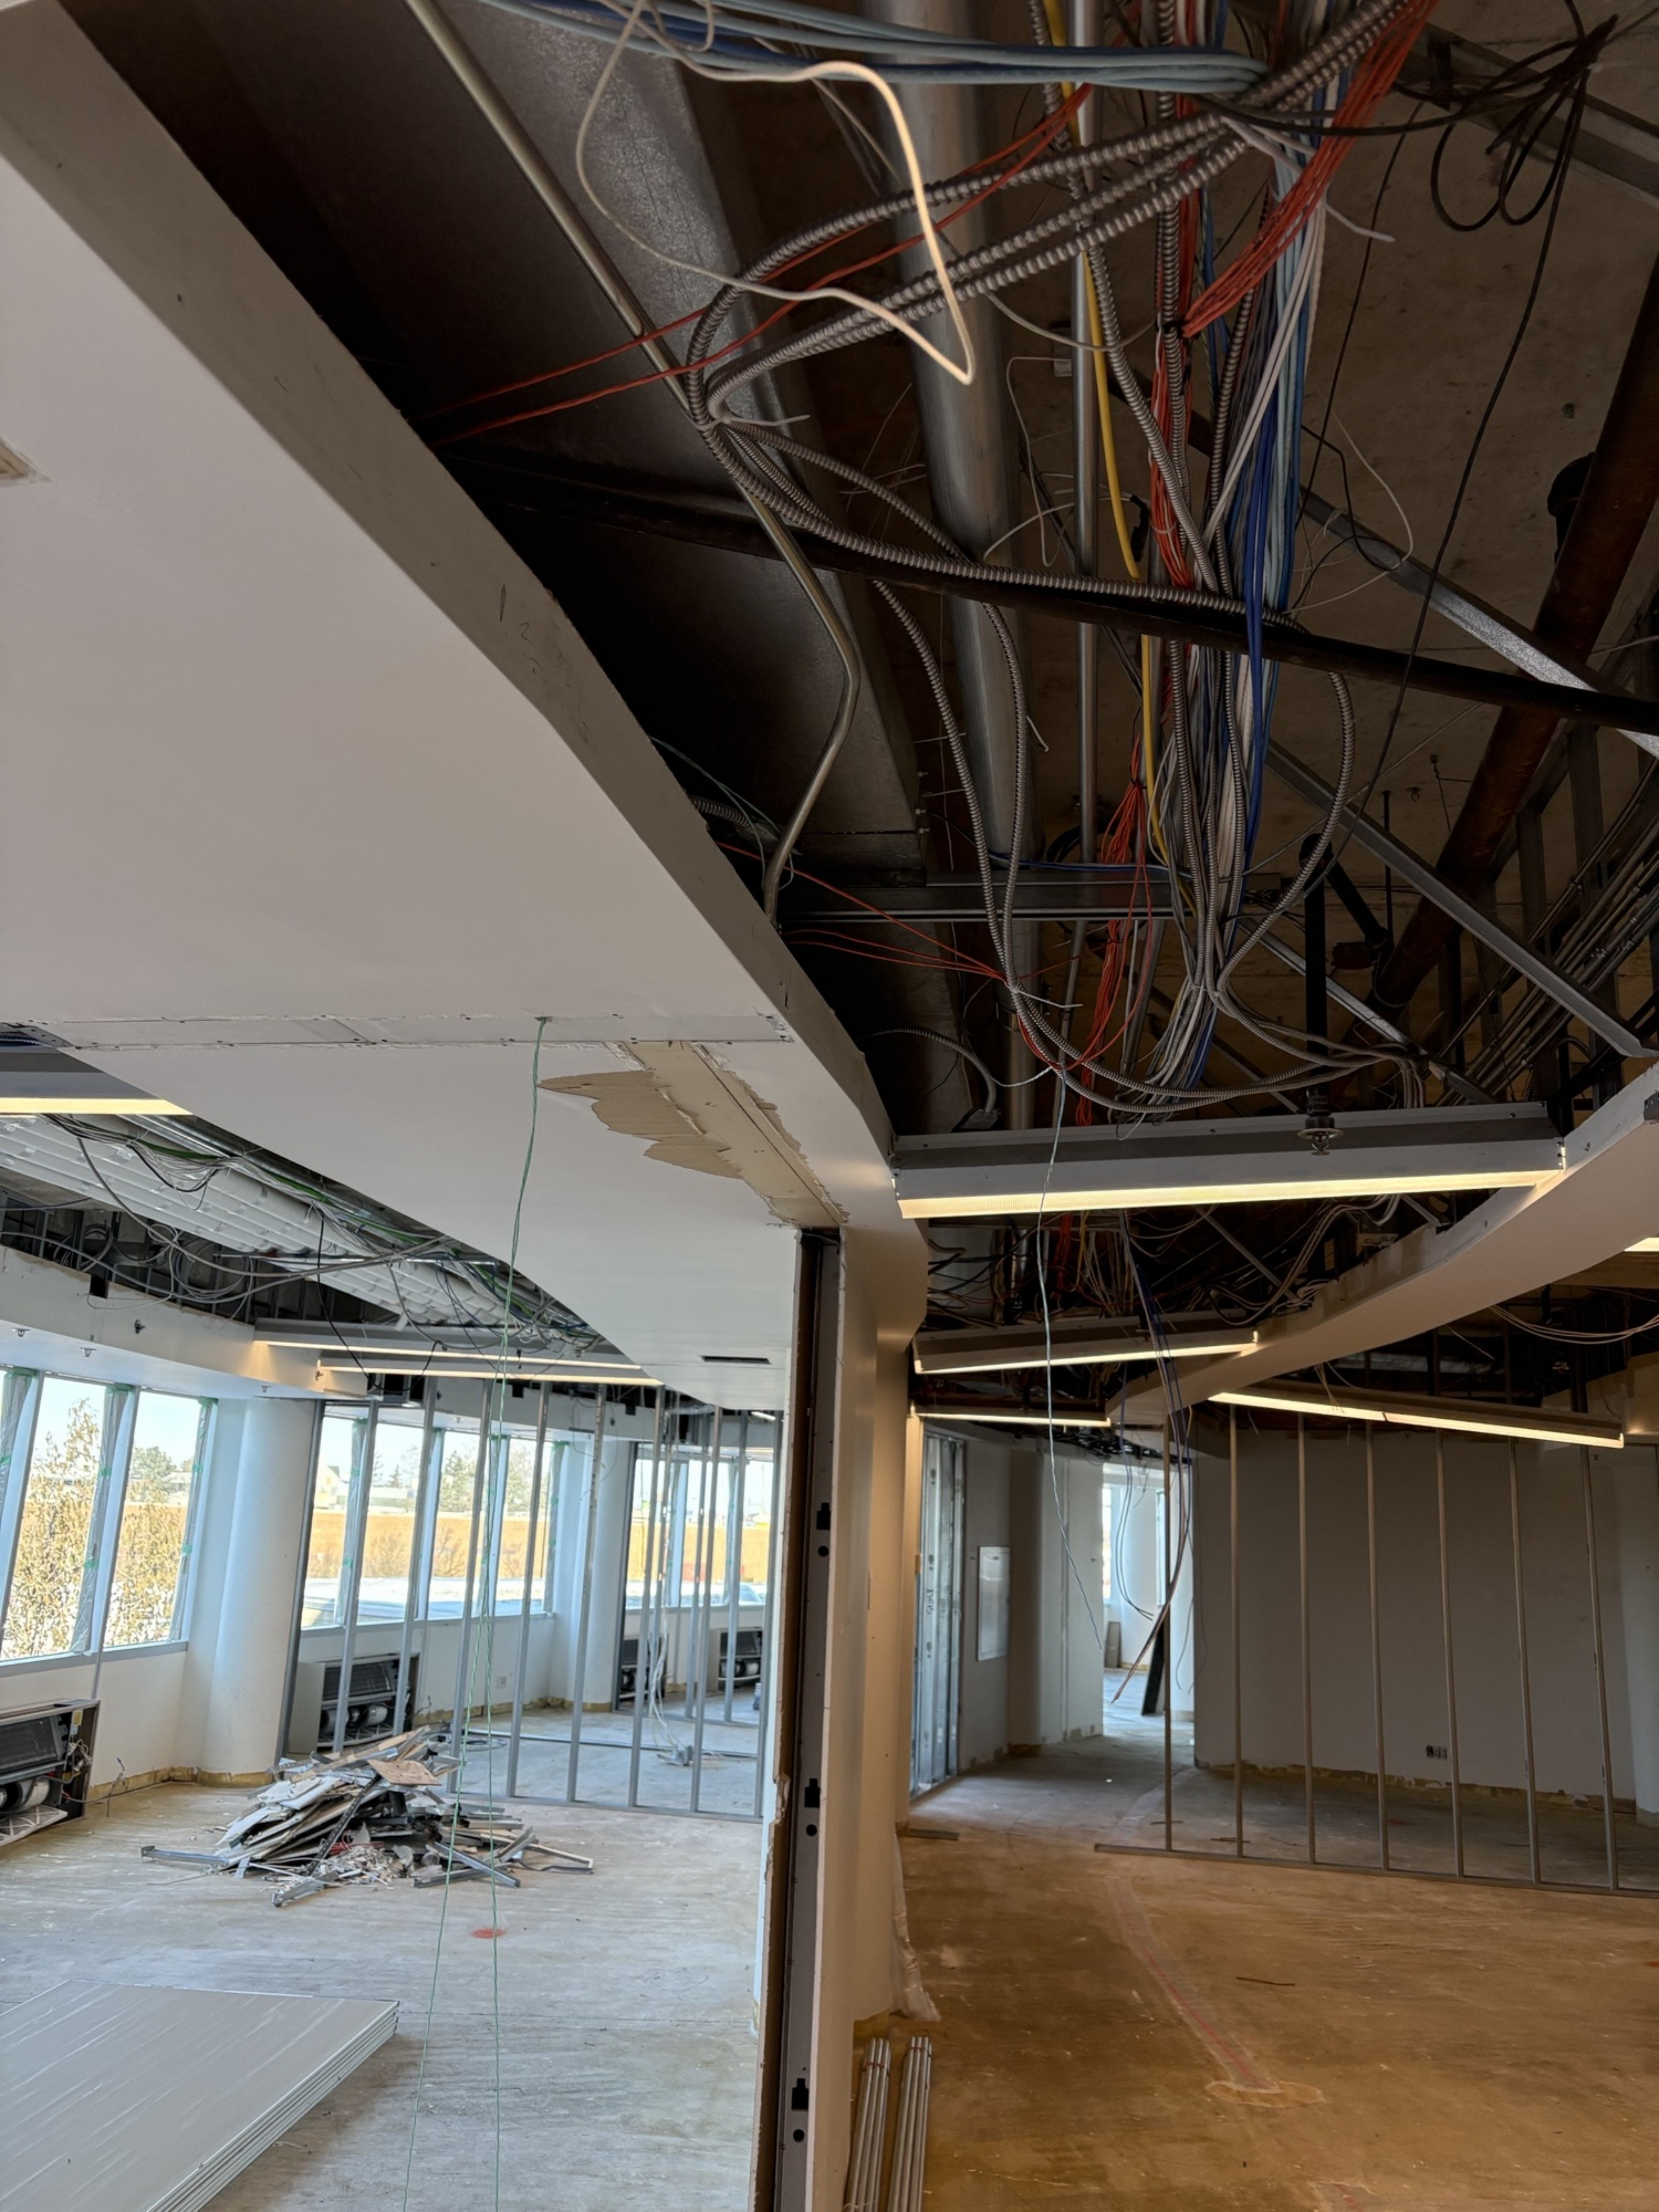
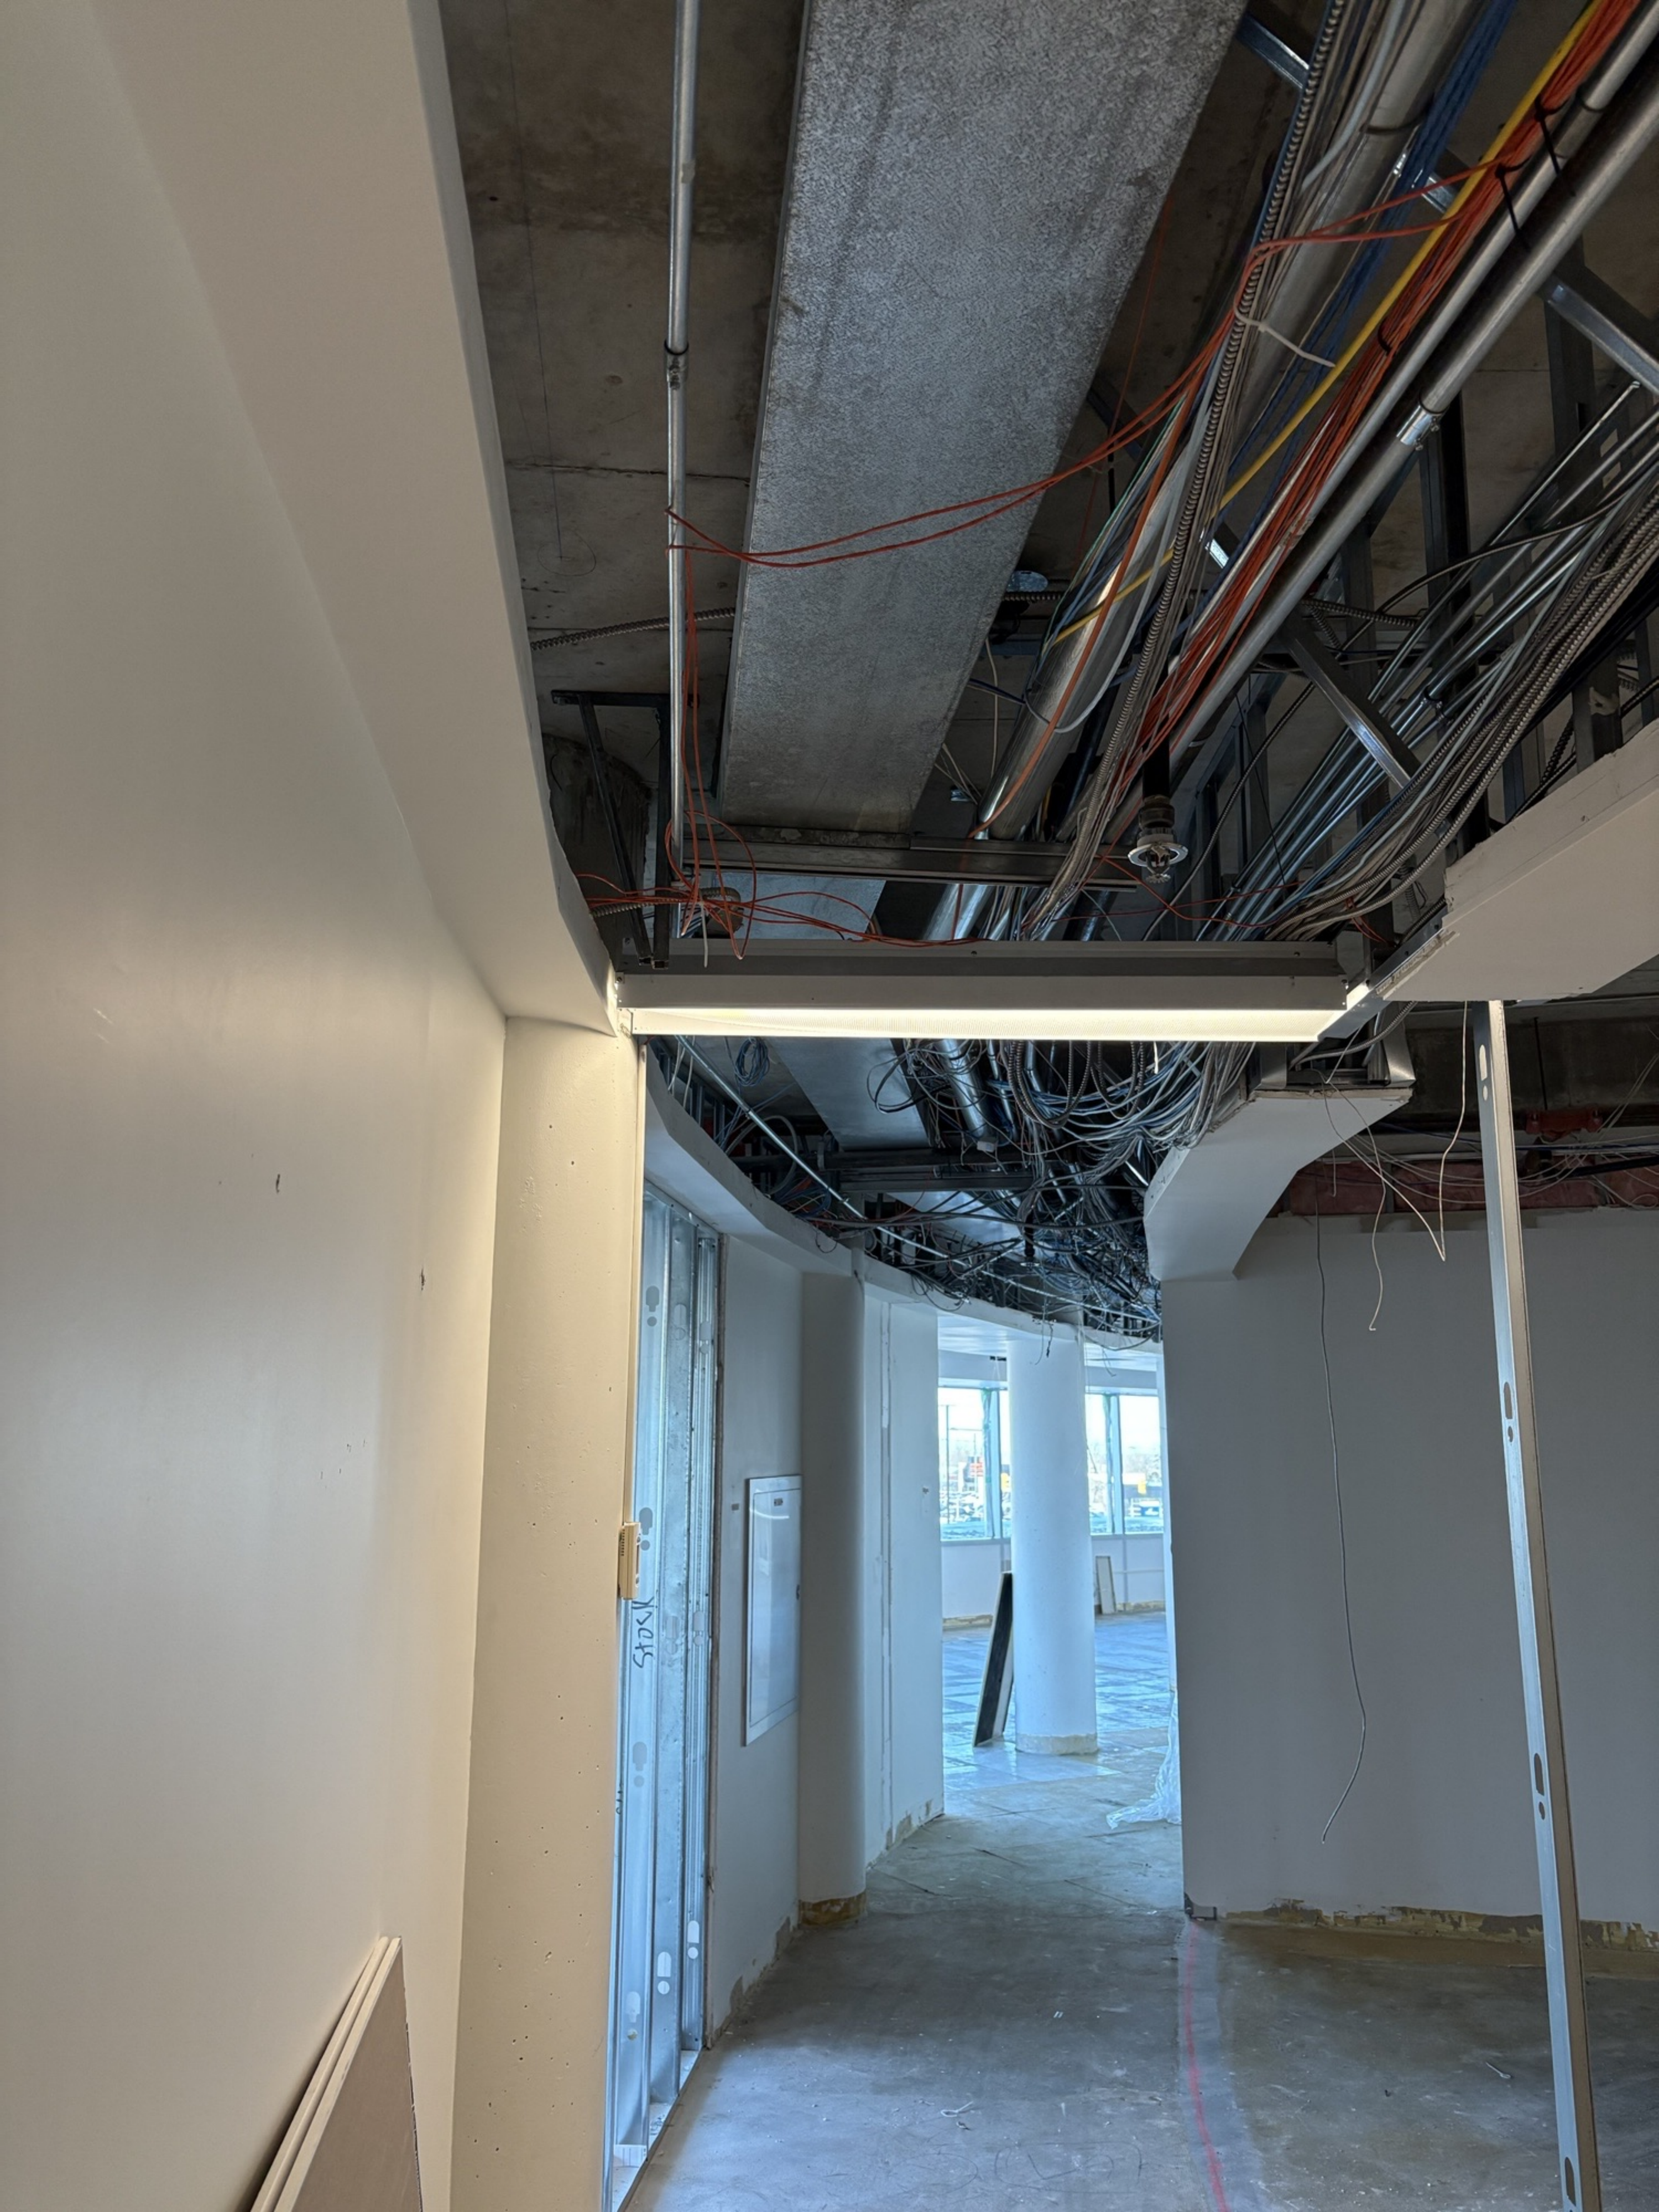
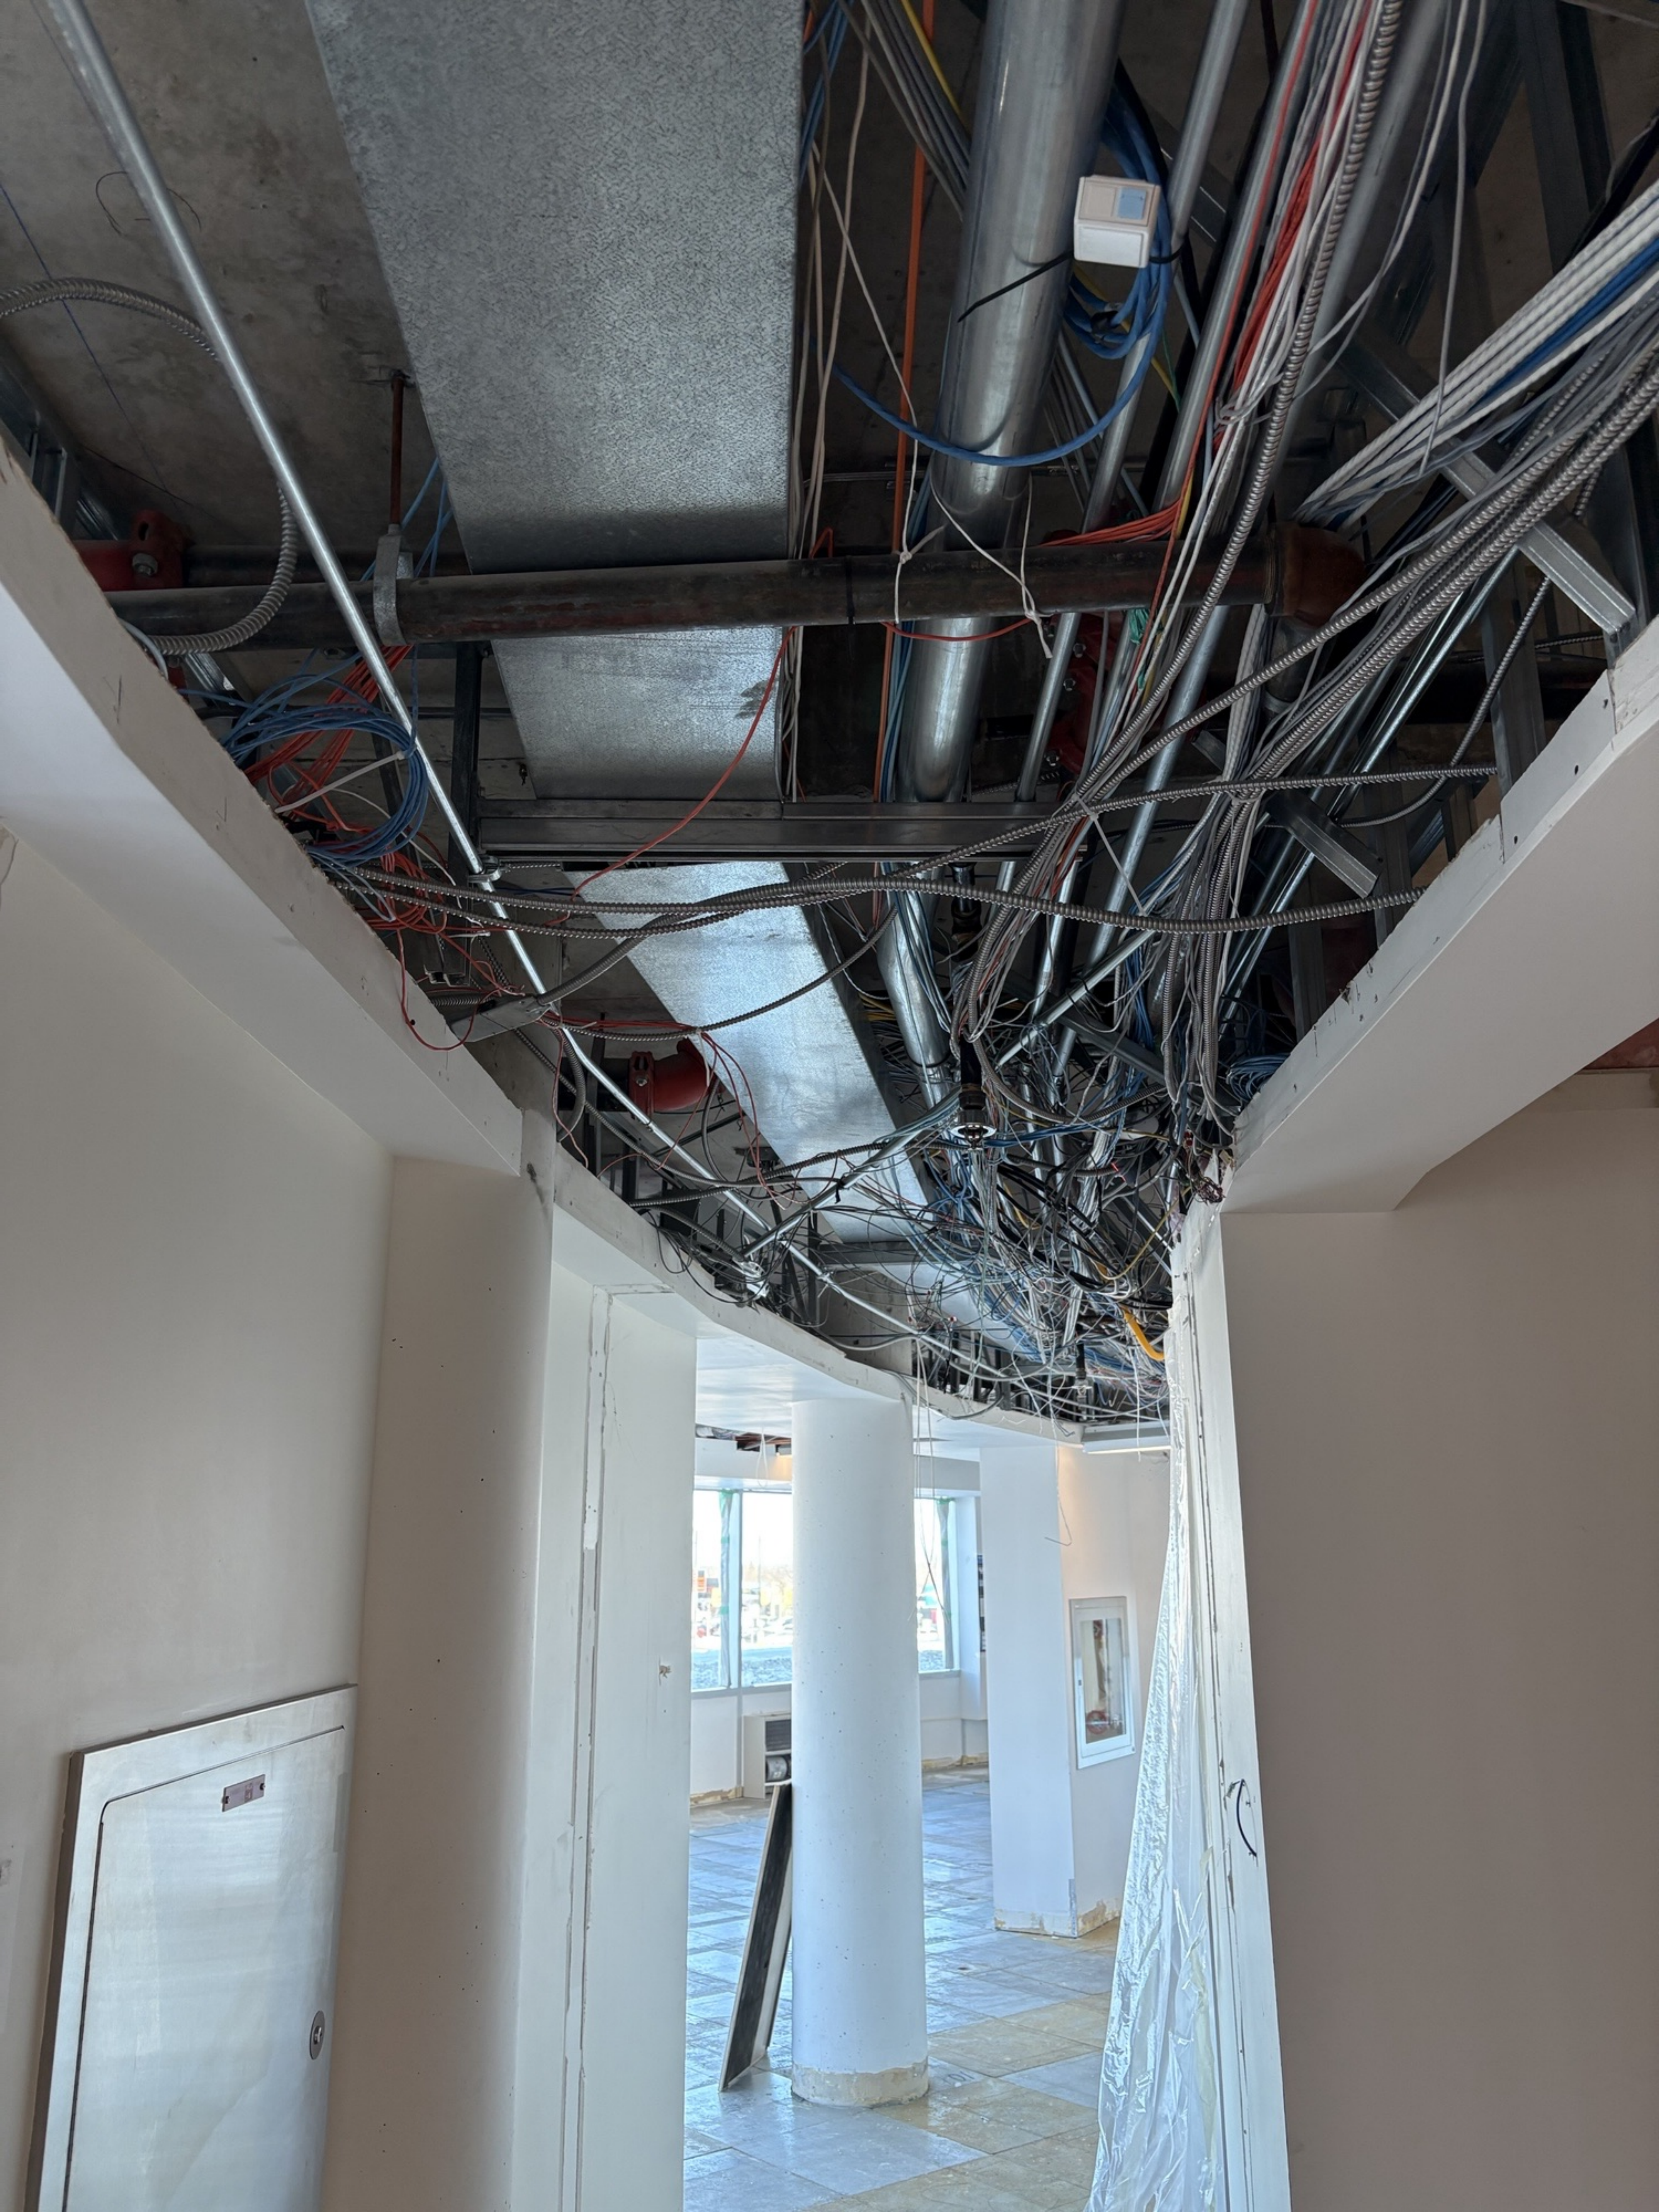
3rd Floor

3rd floor:

On the drawing it shows us running our mains near the column. The current services in the ceiling space have congested that entire area. Please advise on how should we proceed with the location of the new chilled water mains to ensure we are above ceiling height, and don't have to many elevation changes to cause air lock and flow restrictions in the piping system?

1. Ground Floor: Please send us a sketch showing multiple proposed locations for the chilled water riser so that the Furniture Team, Structural, Architect can review and comment.
2. 2nd Floor: Please send us a sketch showing multiple proposed locations for the chilled water riser so that the Furniture Team, Structural, Architect can review and comment.
2. 3rd Floor: Please send us a sketch showing alternate location of the chilled water main routing for our review.
