SEI PROJECT # : 2024-1009

SSHA Scarborough Warming
Centre - Phase 2

Basement
Plumbing Plan Below Slab
New

M1.3

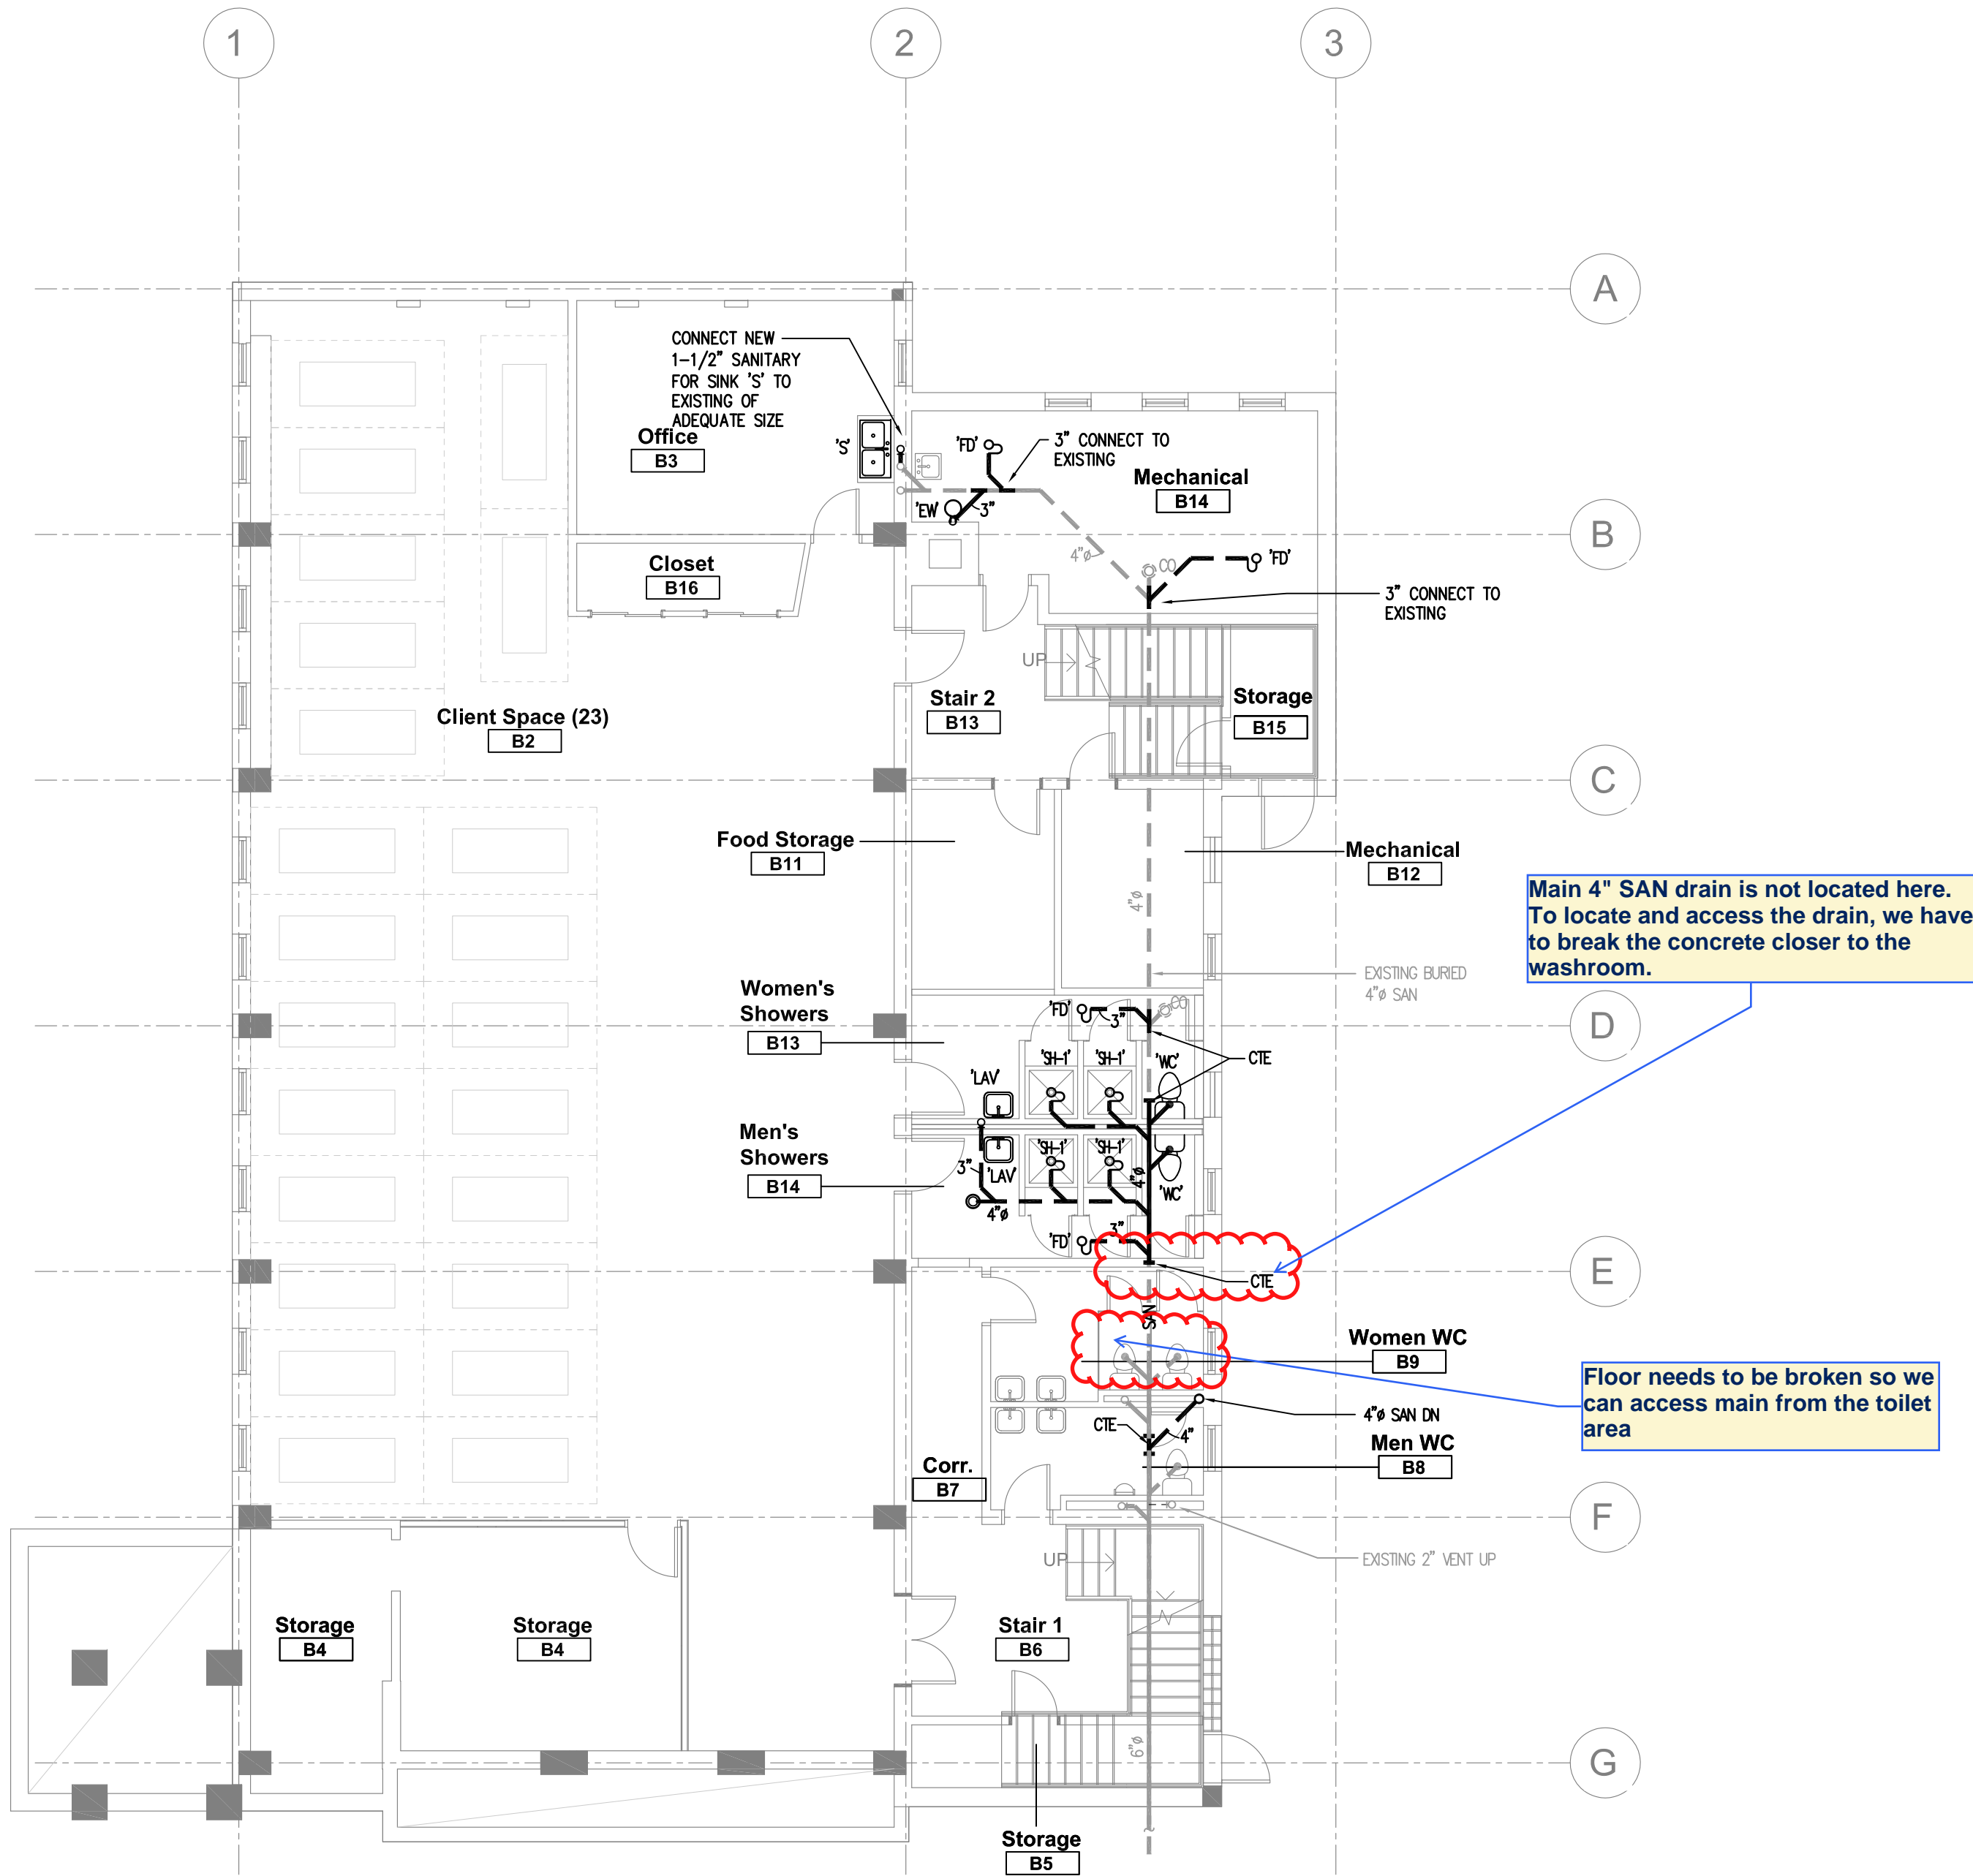
Main 4" SAN drain is not located here. To locate and access the drain, we have to break the concrete closer to the washroom.

Floor needs to be broken so we can access main from the toilet area

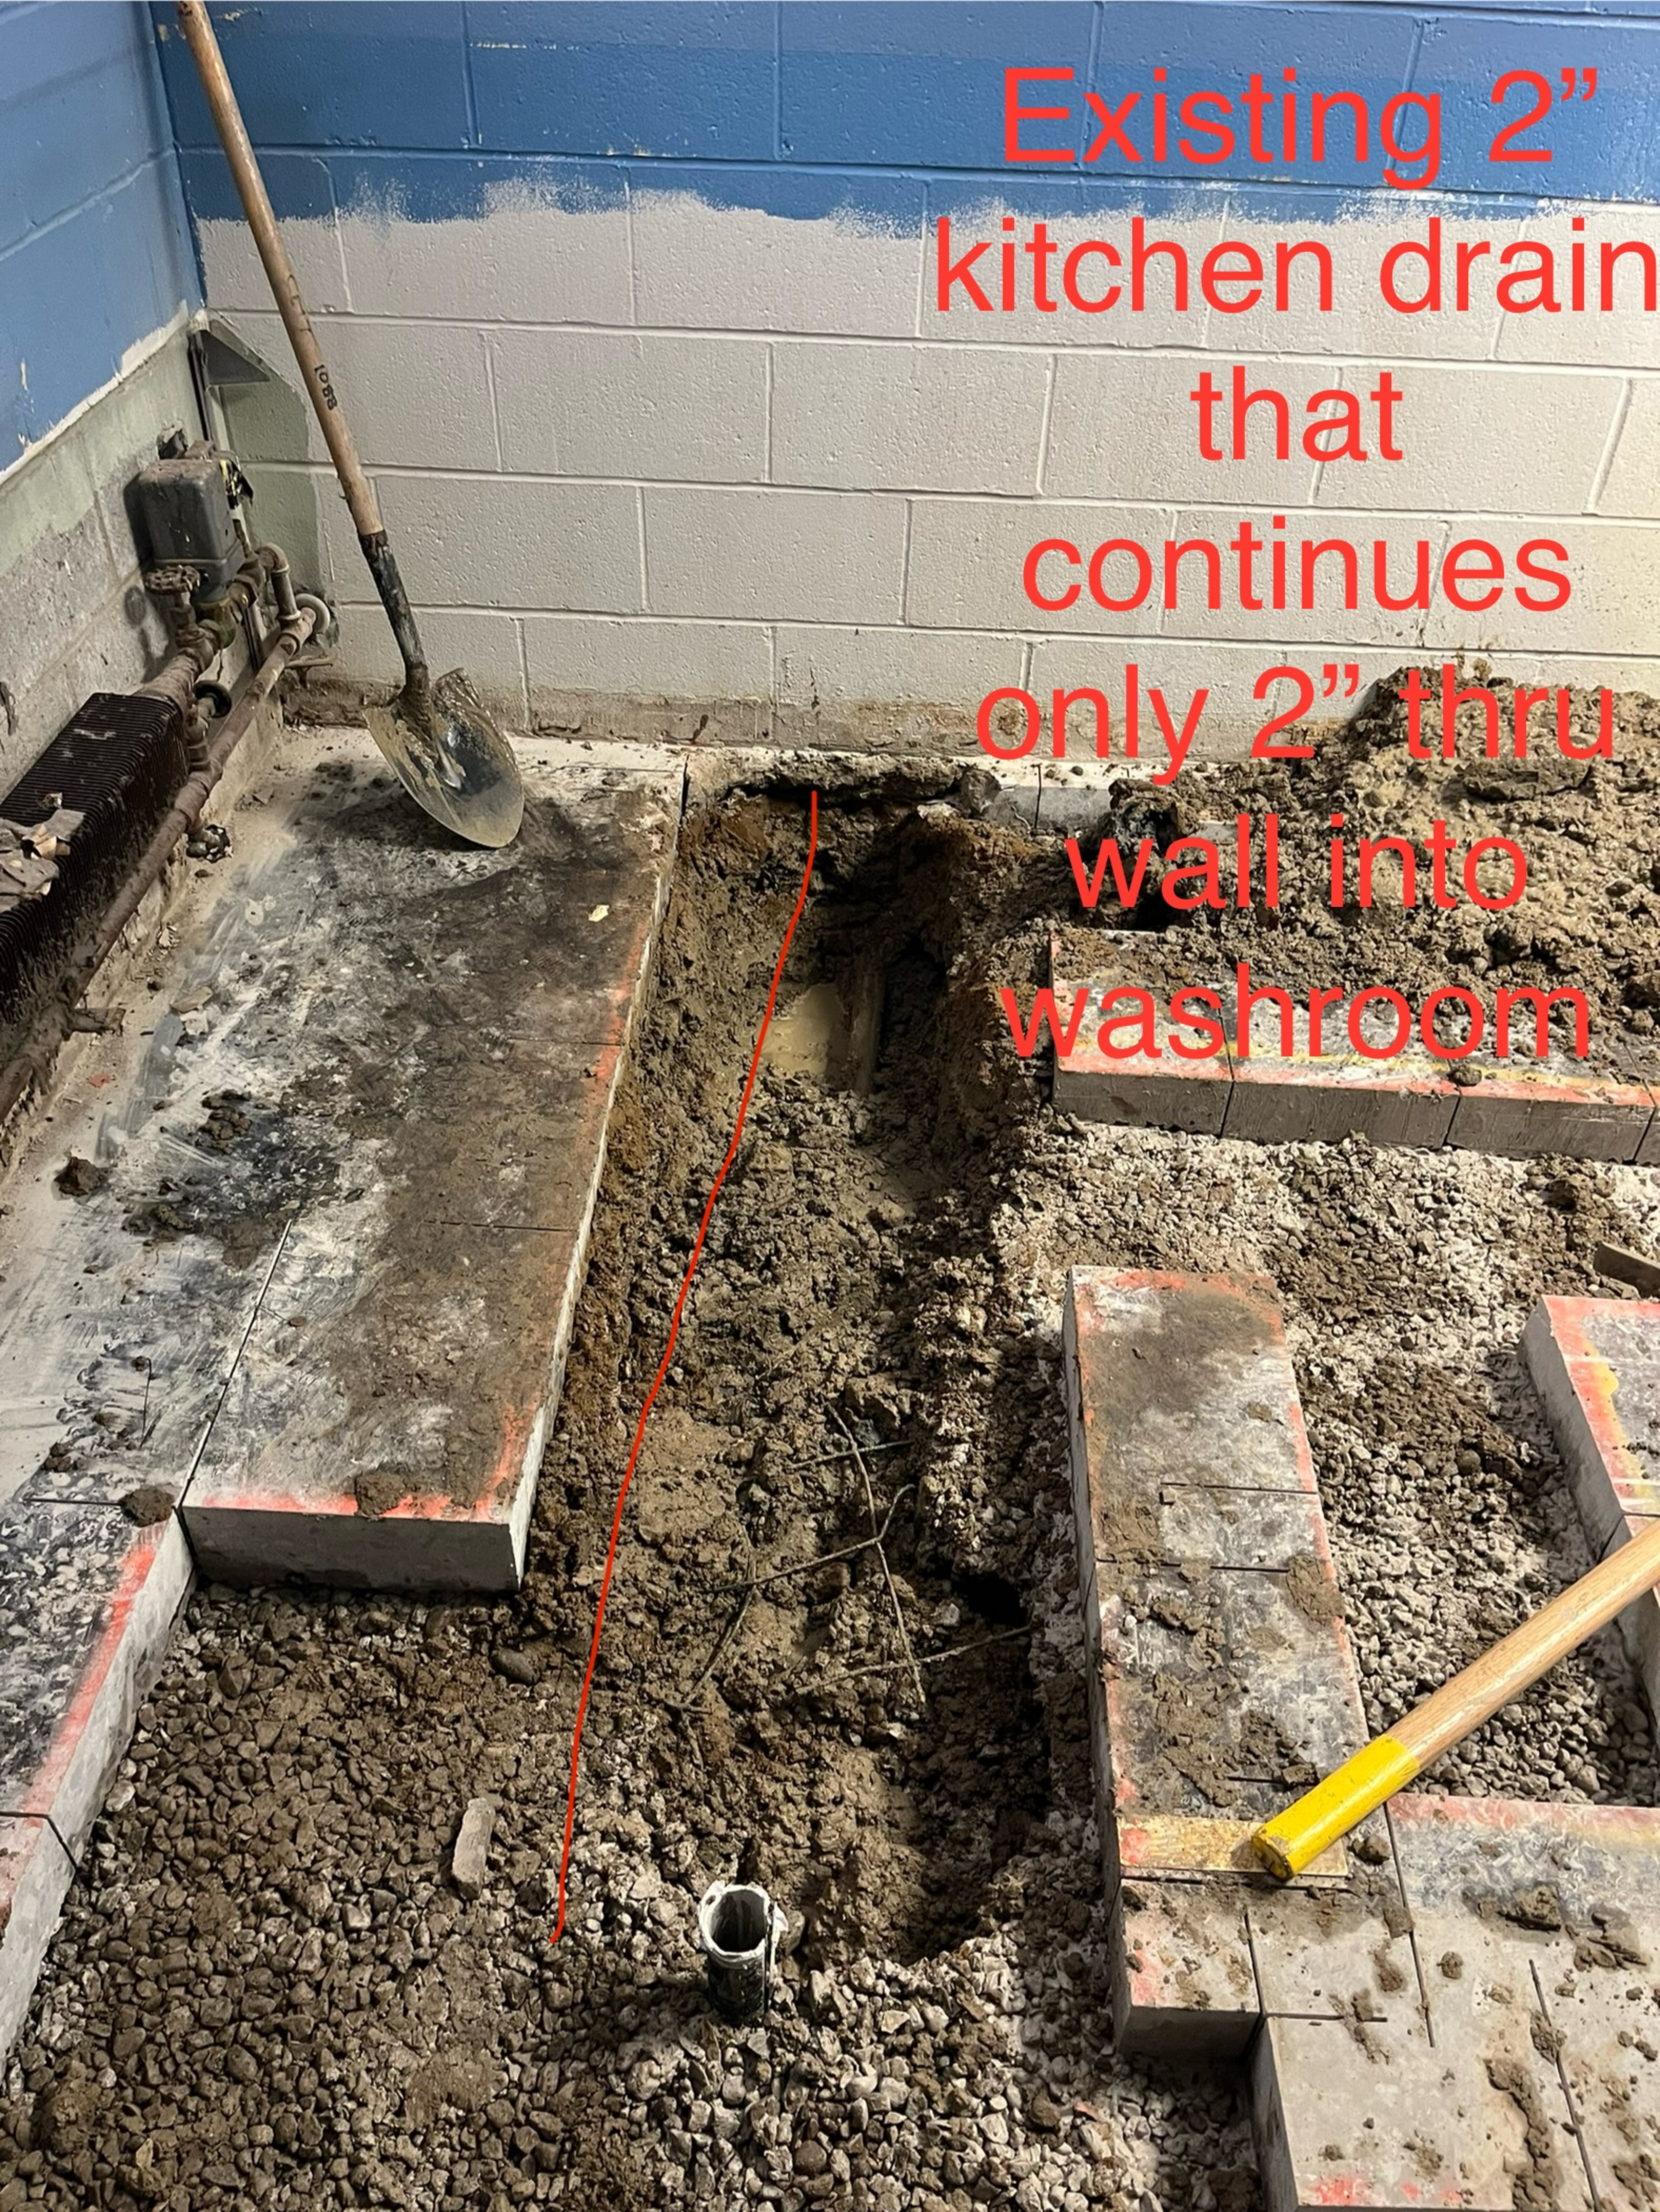
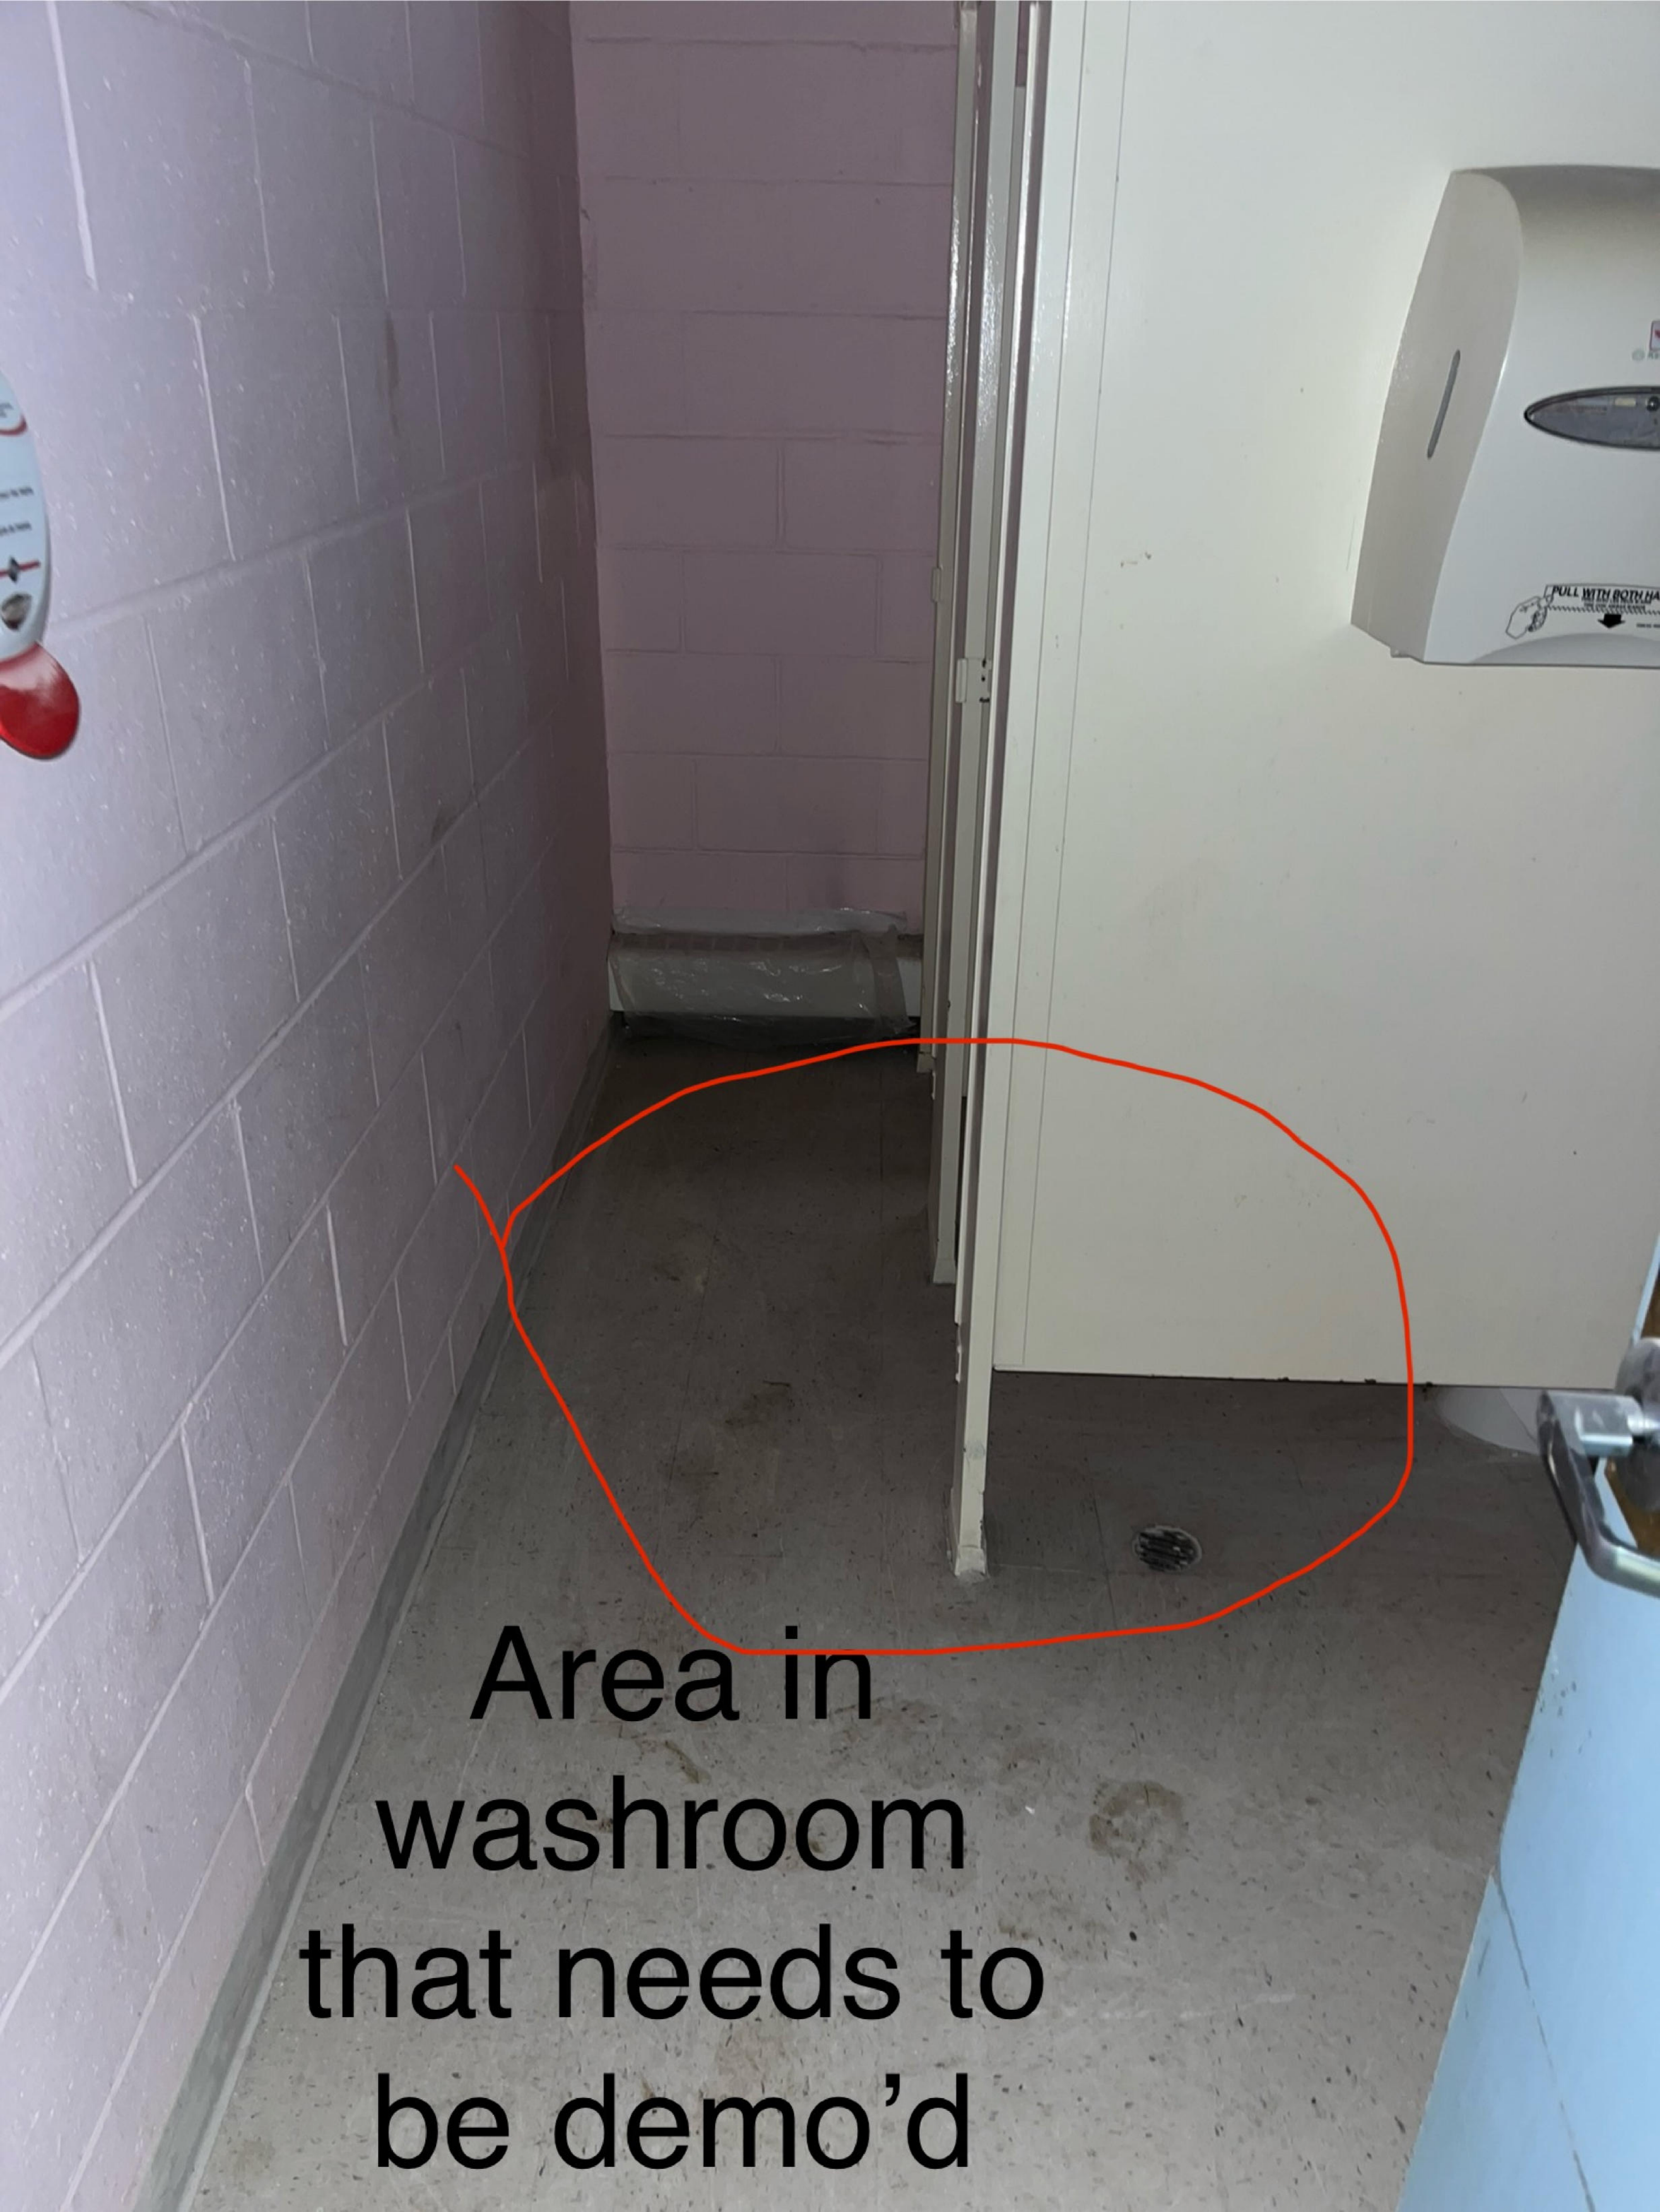
Existing 2"
kitchen drain
that
continues
only 2" thru
wall into
washroom

Area in
washroom
that needs to
be demo'd
